E4416A-11A

S E R V I C E N O T E

Agilent E4416A EPM-P Peak & Average Power Meter

Front Panel Display Problems Caused by Power Assembly Cable

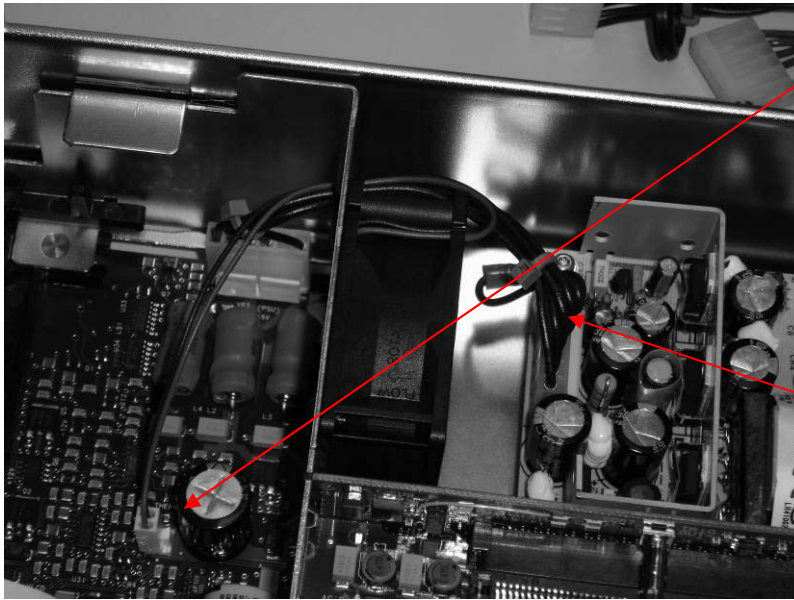
Fan connector

PSU cable New cable is RED in color

- 3) Remove fan connector and PSU cable assembly and replace with new PSU cable assembly E4418-61005. You can differentiate the cable assembly by the colors. The old cable is Black and new cable is RED.

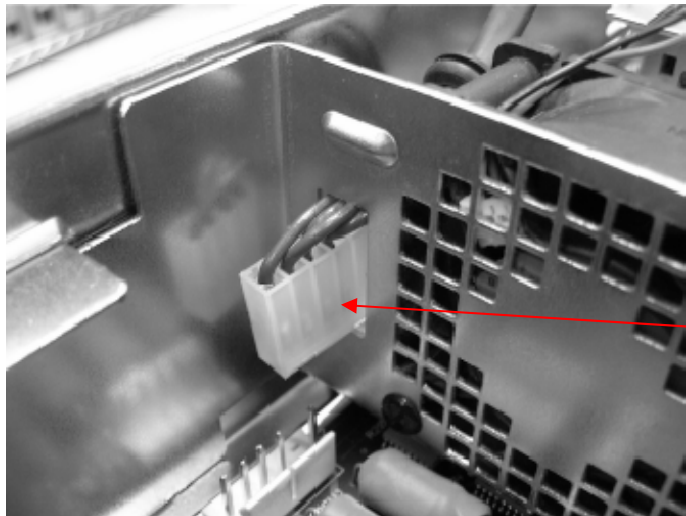
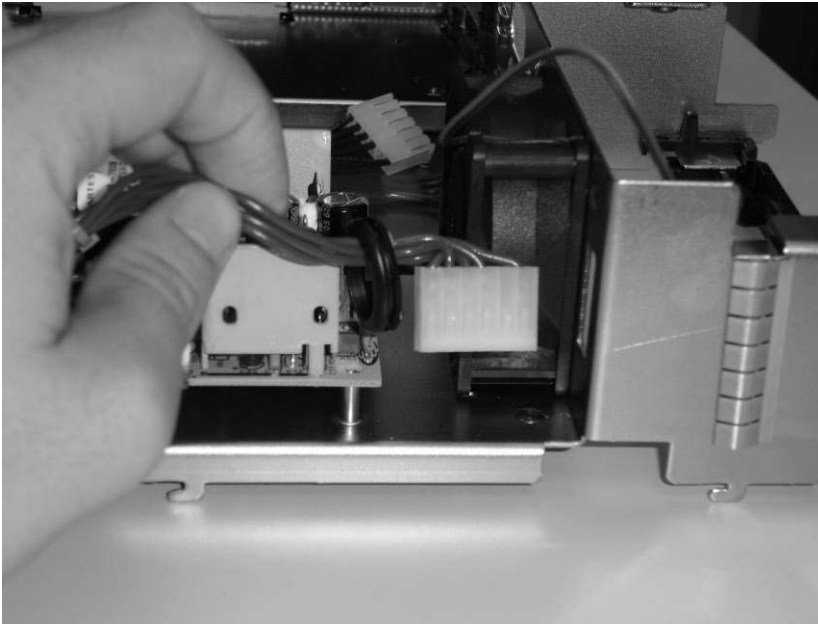
Insert the plastic casing horizontally

- 5) Here are some tips regarding the new cable. Since the plastic casing is slightly bigger in size, so you cannot directly pass through connector through hole. So you need to insert the cable horizontally. See illustration below.

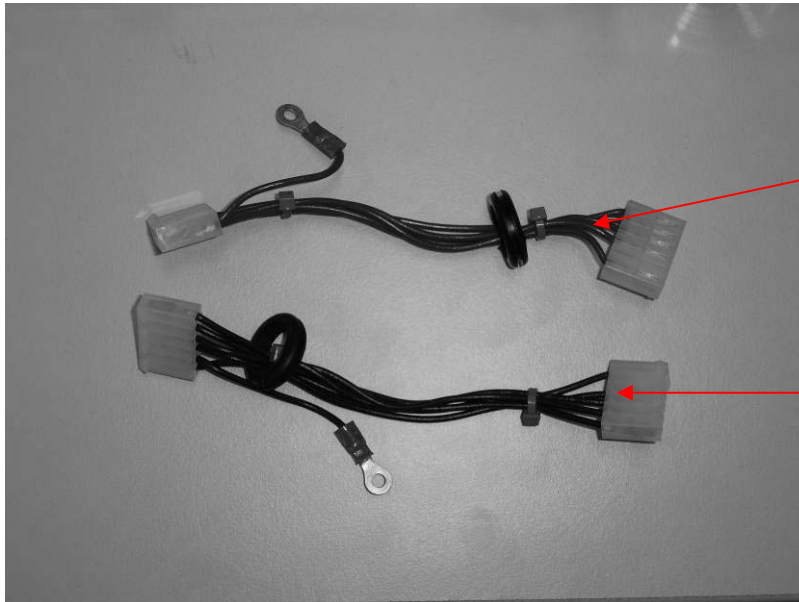
New cable assembly

Old cable assembly

7) Photo below show different of old and new cable. The new cable is red in color whereas the old cable is black in color. The E4418-61005 has 1 ground wire.

Note: If the power cable assembly is red in color, indicates that the cable already been changed. No action is needed.

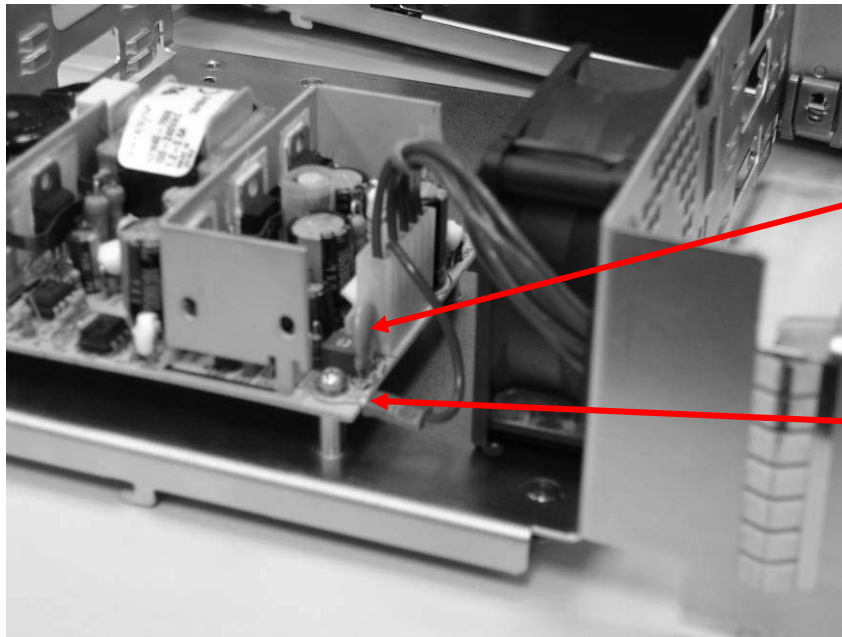
Yellow
Capacitor.

Ground wire
connected to
PCB

10) This picture above shows the ground wire connection to the PCB. Please be aware that the ground connection is very close to the leg of the yellow capacitor. PLEASE DO NOT LET THE GROUND WIRE TOUCHES THE CAPASITOR'S LEG.

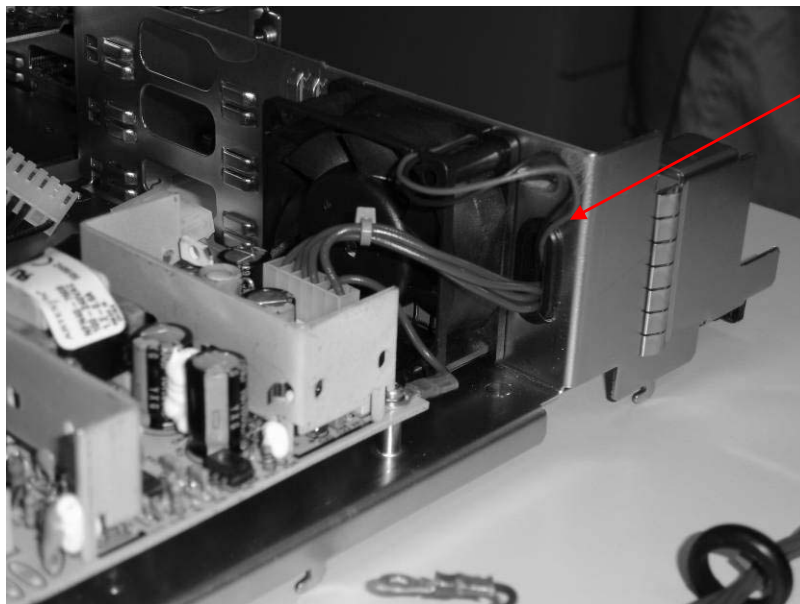
The Fan wire
goes into the
rubber.

- 8) Place back the power supply shield.
- 9) Place back the Cover, Handle and bumpers.
