E4416A-12A

S E R V I C E N O T E

Agilent E4416A EPM-P Peak & Average Power Meter

Front Panel Display Problems Caused by Power Assembly Cable

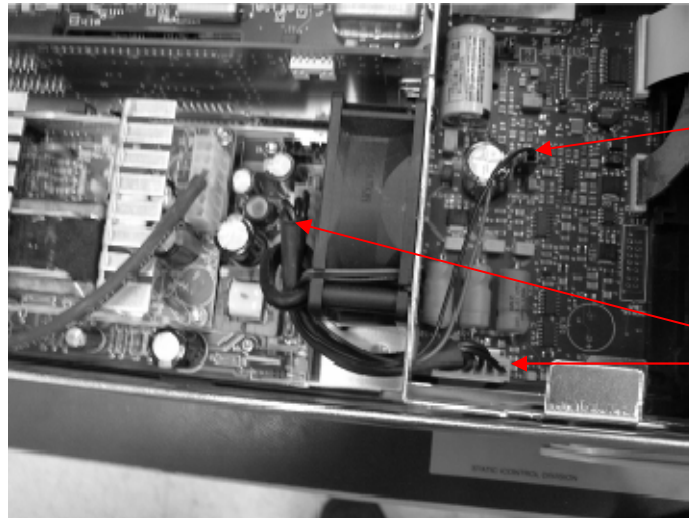
Fan connector

PSU cable assembly, E4418-61029

- 3) Remove fan connector and PSU cable assembly.

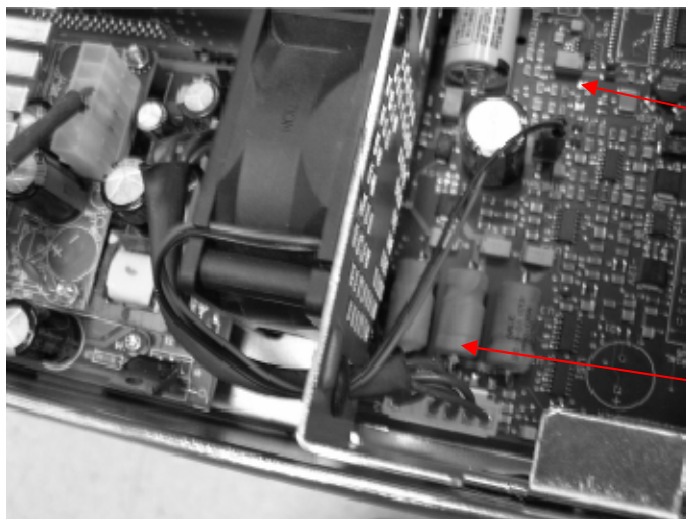
Put back fan connector

New cable with RED color

- 4) Replace with new PSU cable assembly E4418-61029. You can differentiate the cable assembly by the colors. The old cable is Black and new cable is RED.

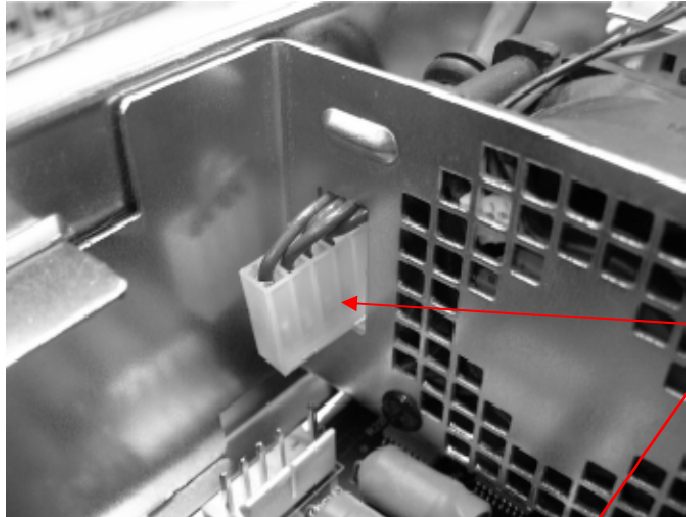
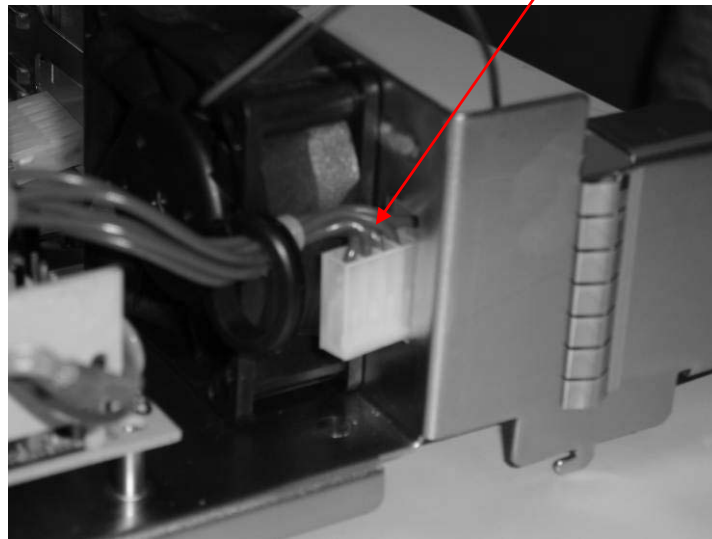
Insert the plastic casing horizontally

- 5) Place back the power supply shield.
- 6) Place back the Cover, Handle and bumpers.
- 7) Here are some tips regarding the new cable. Since the plastic casing is slightly bigger in size, so you cannot directly pass through connector through hole. So you need to insert the cable horizontally. See illustration below.

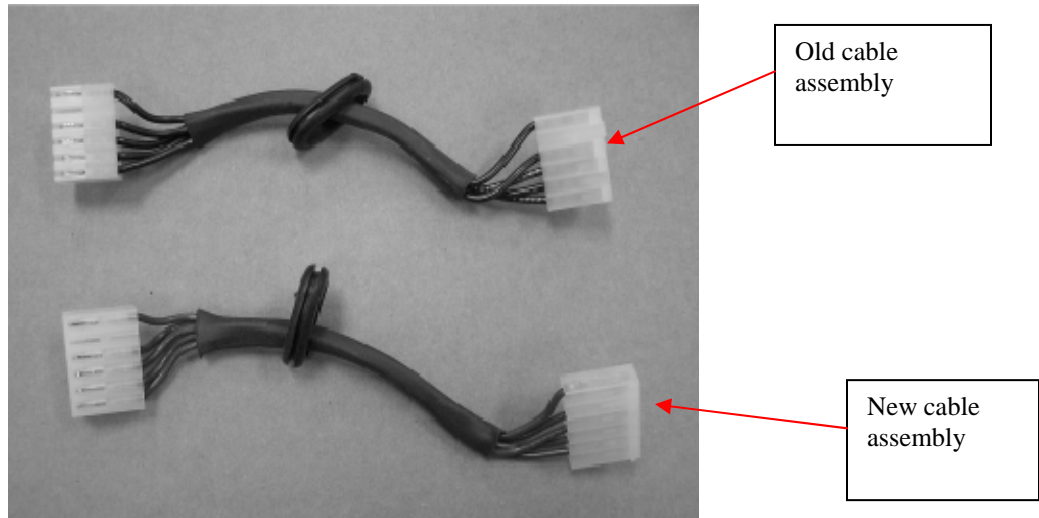
- 8) Photo below show different of old and new cable. The new cable is red in color whereas the old cable is black in color.

Note: If the power cable assembly is red in color, indicates that the cable already been changed. No action is needed.
