E4417A-11A

S E R V I C E N O T E

Agilent E4417A EPM-P Peak & Average Power Meter

Front Panel Display Problems Caused by Power Assembly Cable

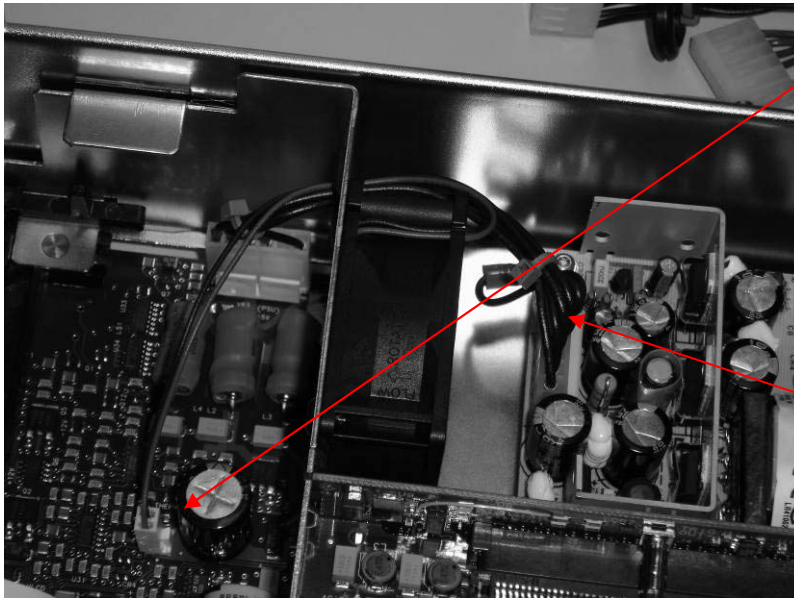
Fan connector

PSU cable New cable is RED in color

- 3) Remove fan connector and PSU cable assembly and replace with new PSU cable assembly E4418-61005. You can differentiate the cable assembly by the colors. The old cable is Black and new cable is RED.

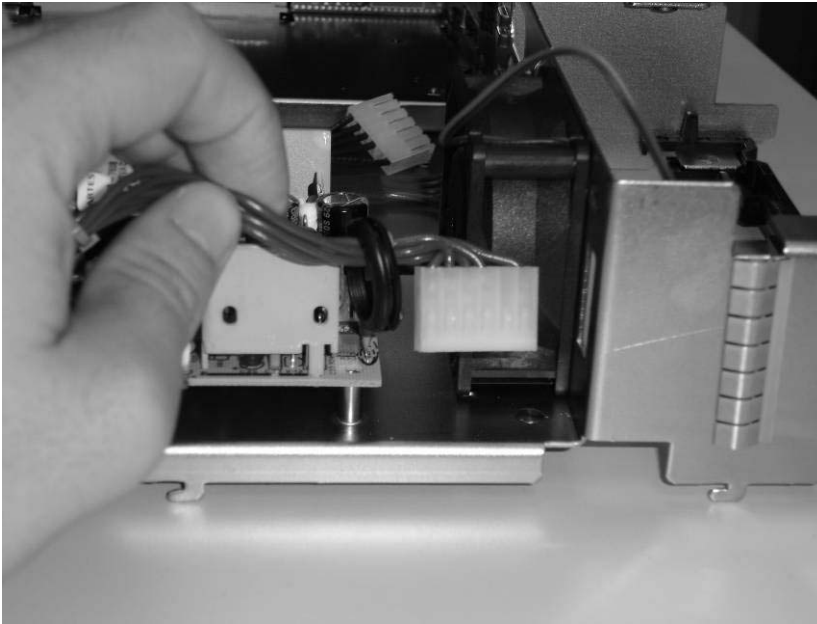
Insert the plastic casing horizontally

- 5) Here are some tips regarding the new cable. Since the plastic casing is slightly bigger in size, so you cannot directly pass through connector through hole. So you need to insert the cable horizontally. See illustration below.

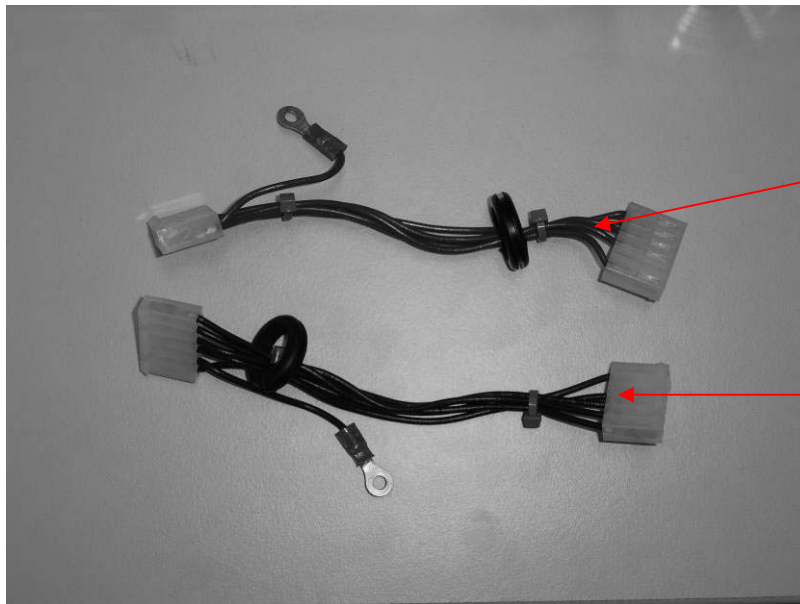
7) Photo below show different of old and new cable. The new cable is red in color whereas the old cable is black in color. The E4418-61005 has 1 ground wire.

New cable assembly

Old cable assembly

Note: If the power cable assembly is red in color, indicates that the cable already been changed. No action is needed.

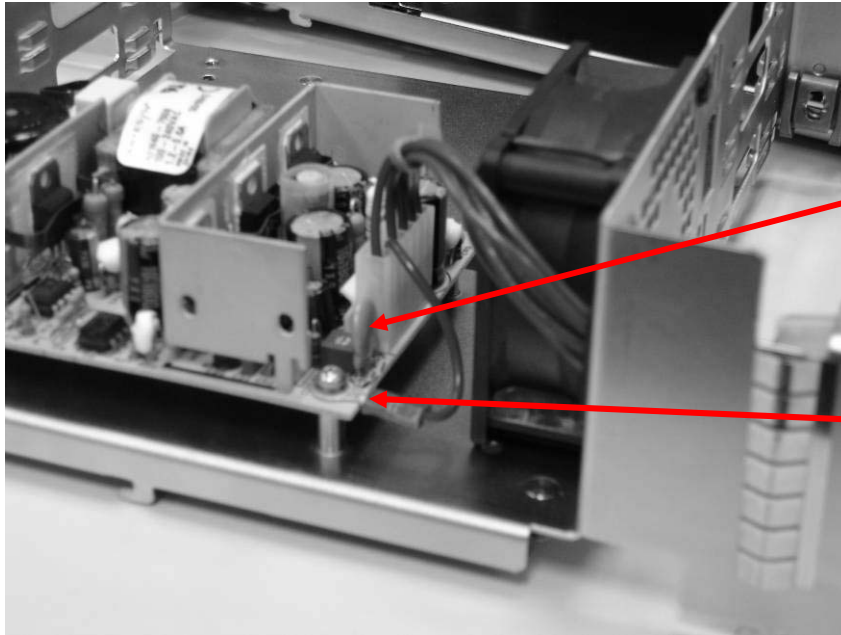
Yellow Capacitor.

Ground wire connected to PCB

10) This picture above shows the ground wire connection to the PCB. Please be aware that the ground connection is very close to the leg of the yellow capacitor. PLEASE DO NOT LET THE GROUND WIRE TOUCHES THE CAPASITOR'S LEG.

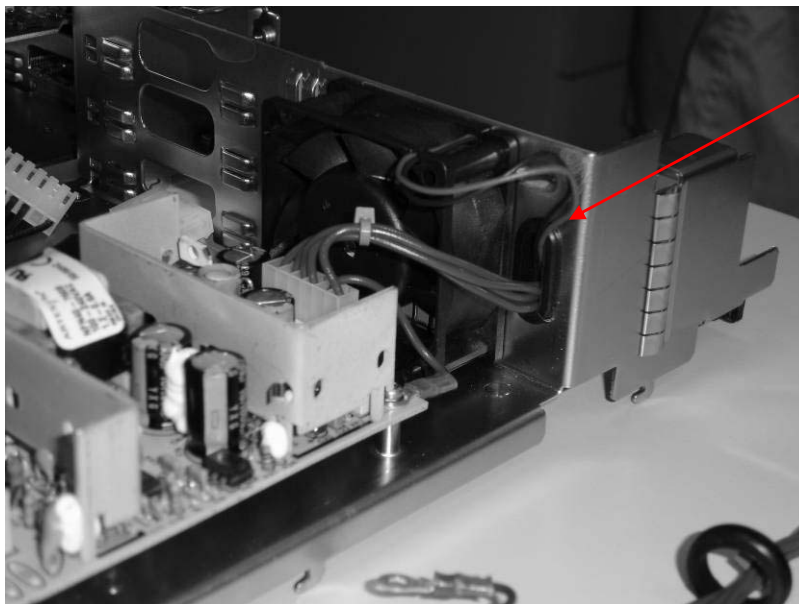
The Fan wire goes into the rubber.
