E4419B-19B

S E R V I C E N O T E

Agilent E4419B EPM Power Meter

Hot plugging problem caused by analog switches (U11) under the measurement board assembly (E4418-60007)

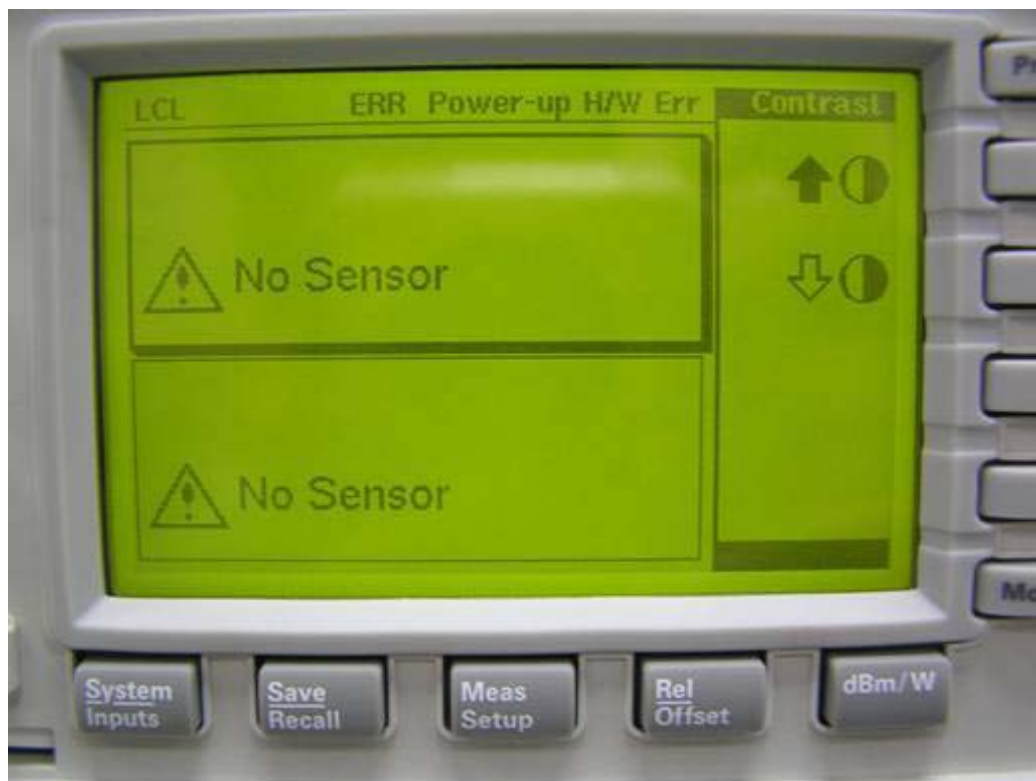
Figure 1: No sensor is detected while sensor is connected

It has been found that analog switch (U11) is causing the hot plugging problem. There are 3 different suppliers who are supplying this part: Analog Device, Vishay and Intersil suppliers. The analog switch supplied by Vishay was found to be contributing to the hot plugging problem. It was a batch related issue that happened in 2005. Current parts do not have this failure.

Replace the problematic measurement board with a good measurement board. After replacing the measurement board, repeat the steps mentioned above to verify that the problem is resolved. It should indicate that sensor is connected even after hot plugging.

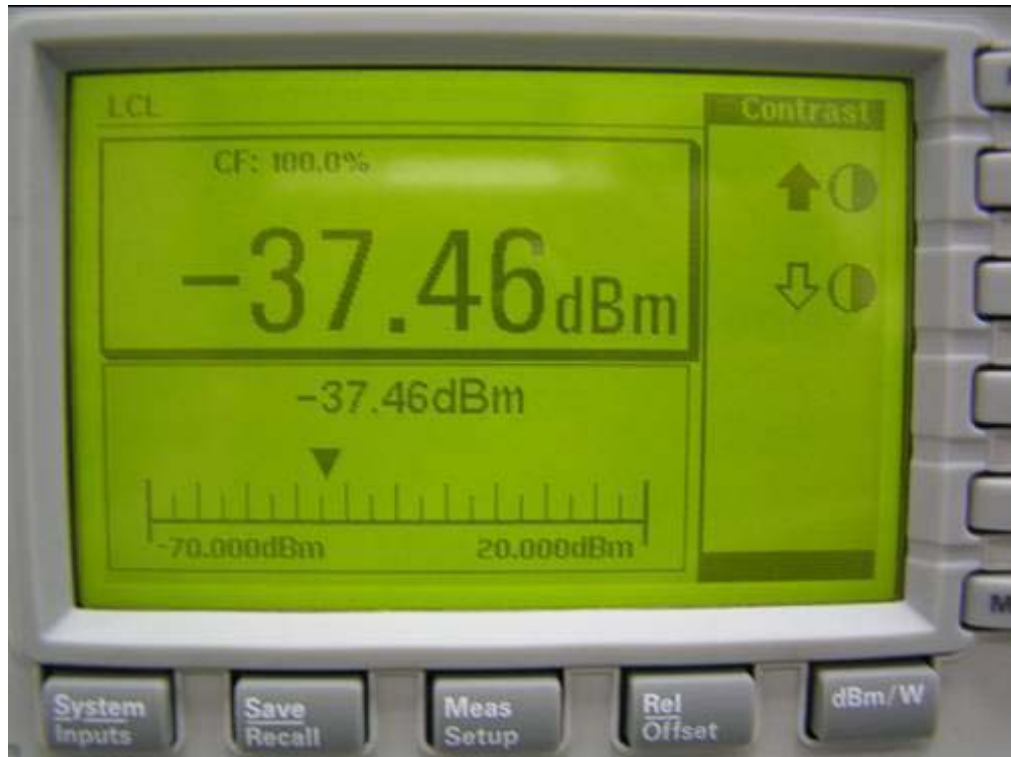
Figure 2: Good measurement board with sensor detected
