E4438C-11

S E R V I C E N O T E

E4438C Vector Signal Generator

Fails Residual FM performance test.

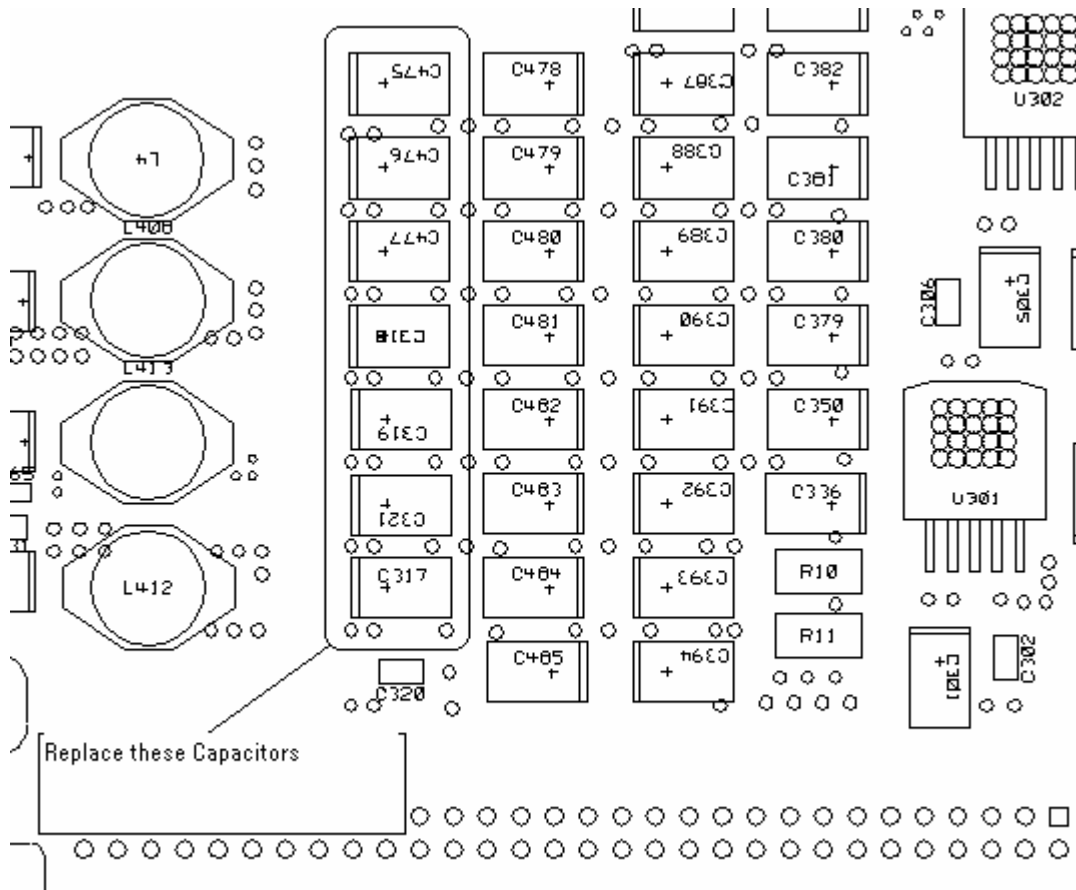
E4438C units that are not option UNJ and do not have the Baseband generator installed may fail the Residual FM performance test. If this happen, check the ESG output for spurs at 1 KHz offset from the carrier.

If the unit fails Residual FM, change the following Capacitors from 330 uF to 470 uF on the Mother board. Capacitors C317, C318, C319, C321, C475, C476 and C477

If parts are not available, Replace the Mother board E4400-60504
