E4447A-04

**S E R V I C E N O T E**

E4447A - PSA Series Spectrum Analyzer

**Internal Alignment Failures for PSA Series Spectrum Analyzers Manufactured Between January 2004 and February 2006 Caused by Low Power Output from A9A1 DRO on A9 Second LO Assembly**

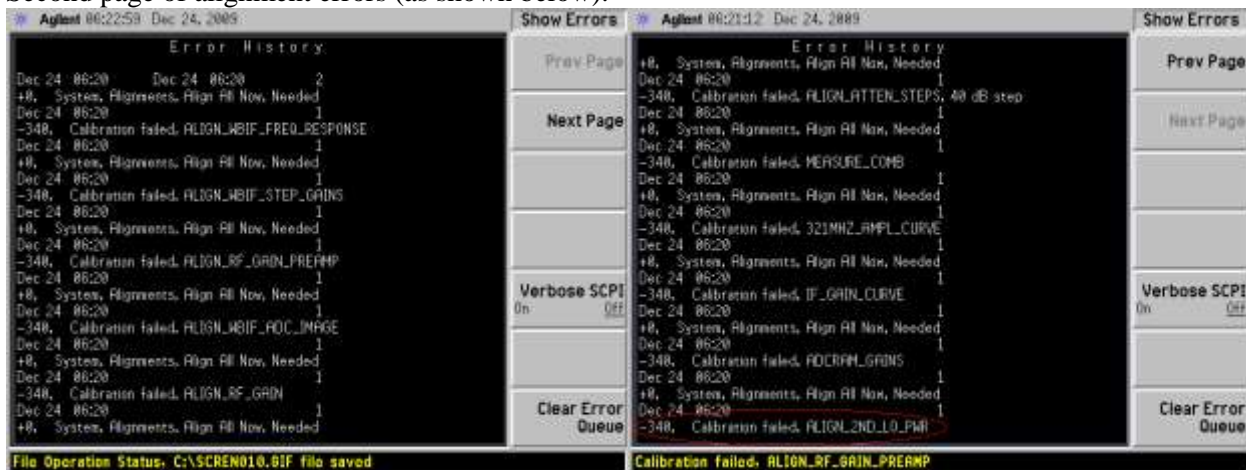
Verify the alignment failure by looking at the error queue for the error message “-340, Calibration failed, Align\_2<sup>ND</sup>\_LO\_PWR”. Press [System] <Show Errors> <Next Page>. Typically, when the Second LO power is too low, it will be the first failure listed in the alignment queue, which will be at the bottom the Second page of alignment errors (as shown below):
