E4448A-15

S E R V I C E N O T E

E4448A - PSA Series Spectrum Analyzer

Internal Alignment Failures for PSA Series Spectrum Analyzers Manufactured Between January 2004 and February 2006 Caused by Low Power Output from A9A1 DRO on A9 Second LO Assembly

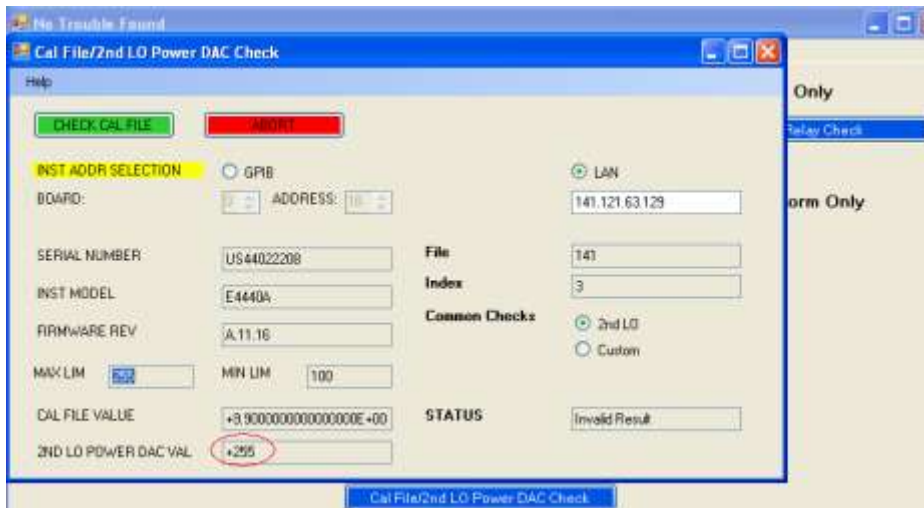
A value of +255 for the Second LO Power DAC Val will be returned if the analyzer is not able to set enough gain to the Second LO amplifier on the A20 low band assembly if the DRO power output is too low. The lower the DAC value reported is, the more gain the low band amplifier is using. When the low band amplifier is no longer able to provide enough gain, the DAC value rolls from 0 (most gain) to 255 (least gain), causing the internal alignments to fail.
