E4980A-01B

S E R V I C E N O T E

E4980A Precision LC Meter 20 Hz to 2 MHz

Power supply for E4980A might be defective due to its design

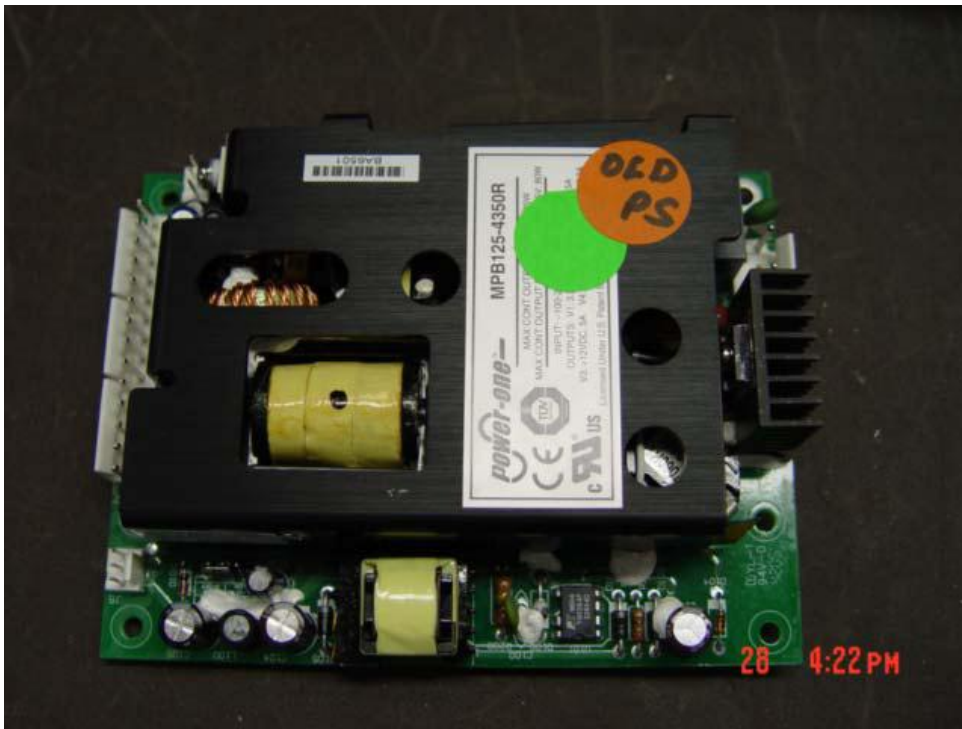
The E4980A specified above serial numbers contain the power supply that might be defective due to a problem in its design by a third company.

For MY46100102 to MY46100134, the power supply has the sticker on which “OLD PS” is written as shown in the figure below.

Replace the old power supply with the new one (p/n 0950-5146).

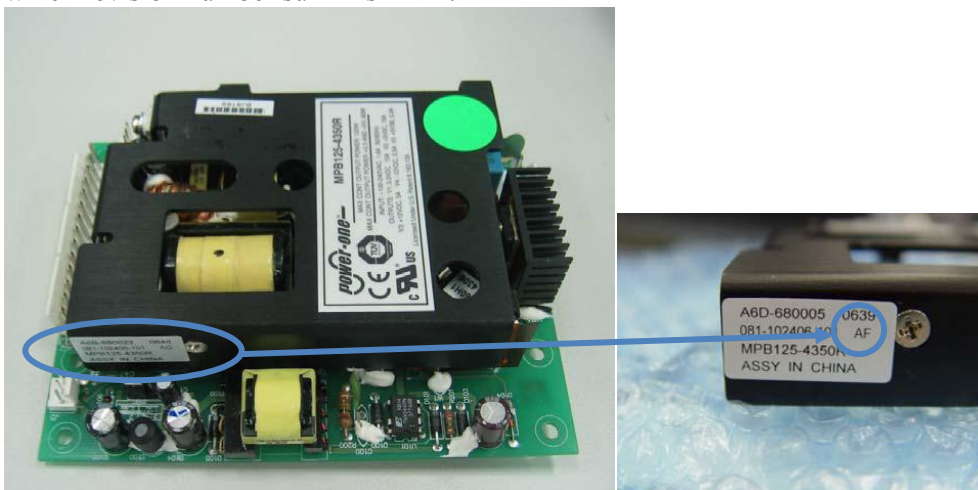
For MY46100889 to MY46101187 and SG46100109, the power supply has the MPN sticker with which revision number suffix is “AF”.
