**E5061B-02**

**S E R V I C E N O T E**

"E5061B Network Analyzer, 5 Hz to 3GHz"

**A screw for heat sink of CPU board might become loosened.**

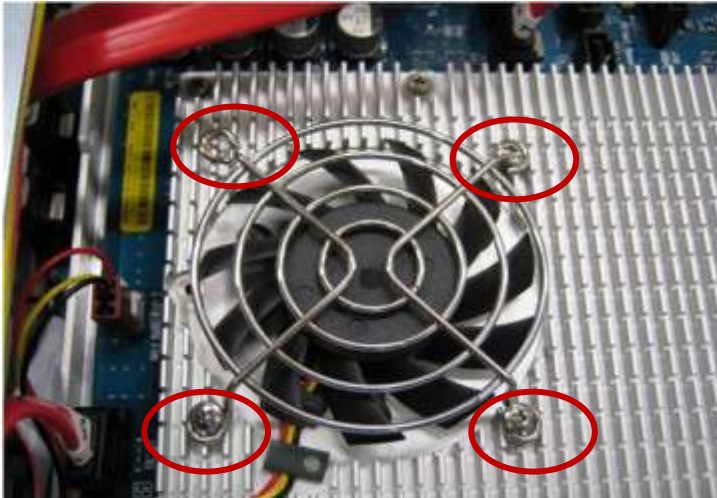
A screw for heat sink of CPU board might be loosened or removed, due to wrong screw position.

Step-1. Check that all four screws are NOT removed.

In case a screw is removed, find the screw in the box, to prevent circuit short out.

When the screw is found, go to Step-2.

When the screw is not found, replace the CPU board.

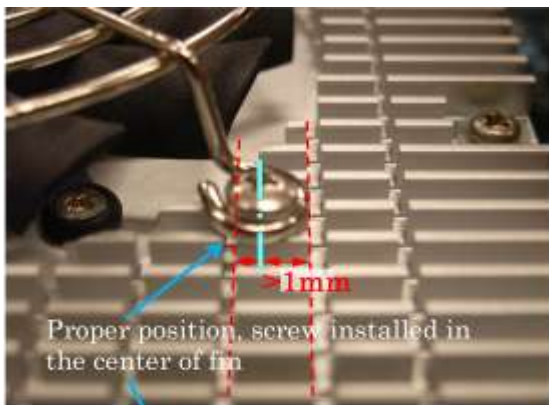
Right Position

Step-2. Check the positions of all the four screws.

In case of Wrong position of the screw, remove the wrong position screw and tighten the screw with Right position.
