E5061B-05

S E R V I C E N O T E

E5061B Network Analyzer, 5 Hz to 3GHz

Compatibility issue between Touch Screen Controller and HDD

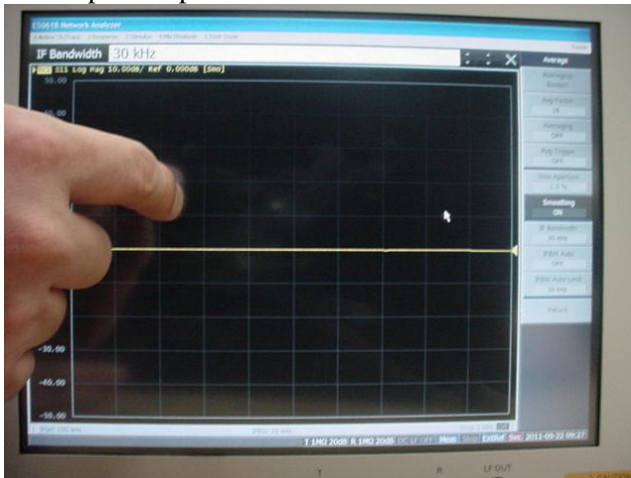
When there is incompatibility between Touch panel controller and HDD, finger pointed place and the mouse pointer place is different.

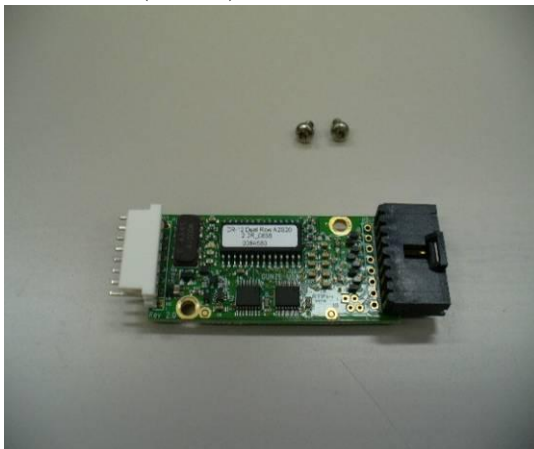
5012-8672 (DR-12) Picture

5012-8672, DR-12 Touch Screen Controller board needs DR-12 driver on the HDD. The DR-12 driver is in the E5061-82201 HDD only.

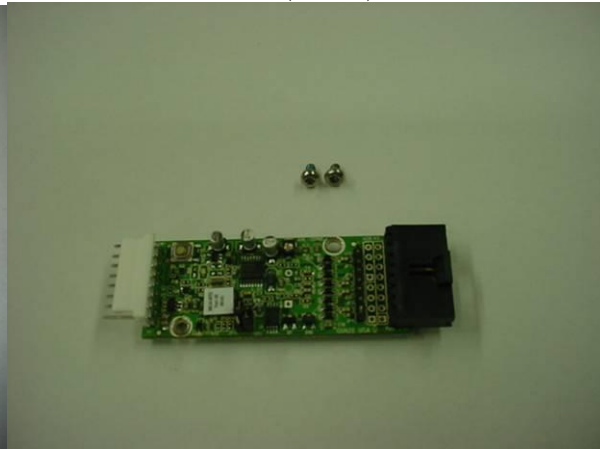
0960-2972 (SR-10) Picture

0960-2972, SR-10 Touch Panel Controller needs SR-10 driver on the HDD. The SR-10 driver is in the E5061-82202 HDD only.
