E5071B-14

S E R V I C E N O T E

E5071B ENA Series Network Analyzer, 300 kHz to 8.5 GHz

Firmware update is failed with CP300 HDD image, while updating firmware to FW Rev.A.08.00 or later

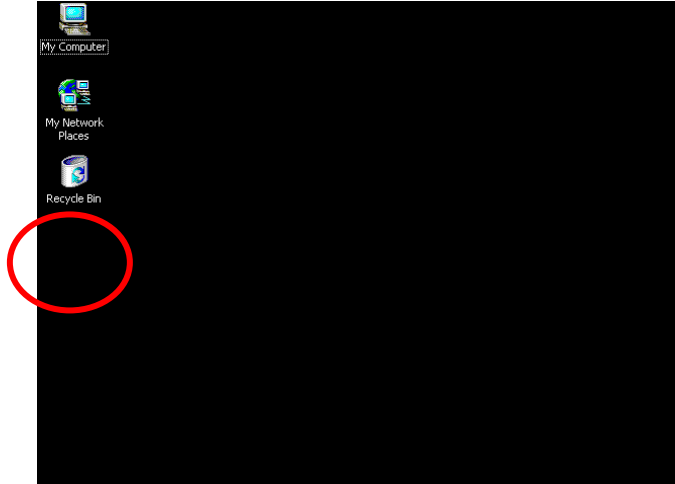
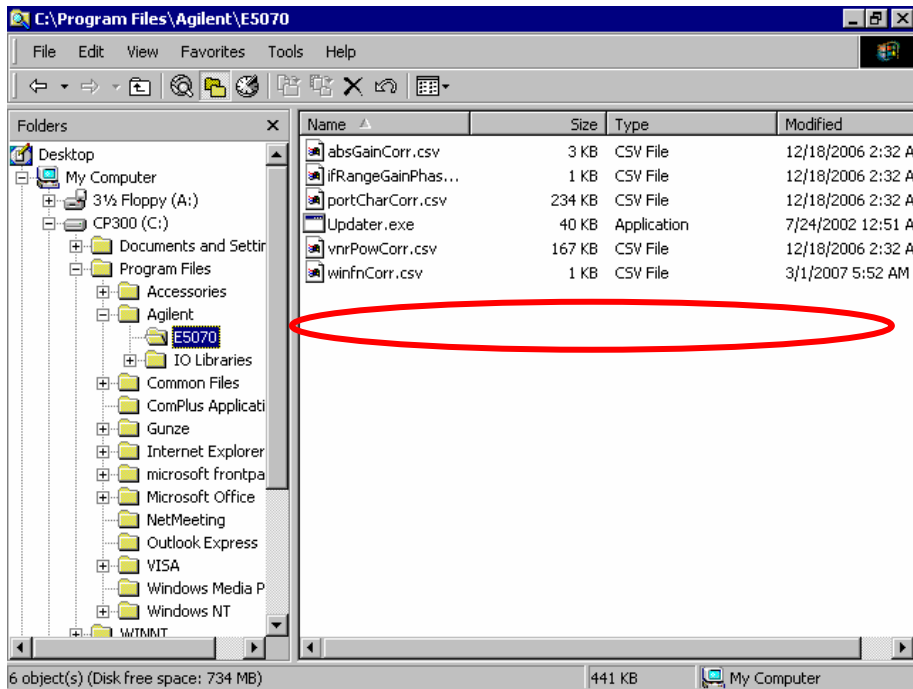
If a customer updates the firmware to FW Rev.A.08.00 or later with CP300 HDD image, firmware update is failed and most of the firmware files are deleted.

Network Analyzer shortcut on the Desktop, E5070.exe on the \Program Files\Agilent\E5070 directory are deleted.
