E5071C-08

S E R V I C E N O T E

E5071C - ENA Series Network Analyzer, 9 kHz to 20 GHz

The measurement data is unstable due to a Receiver Port degradation, though a user performs calibration.

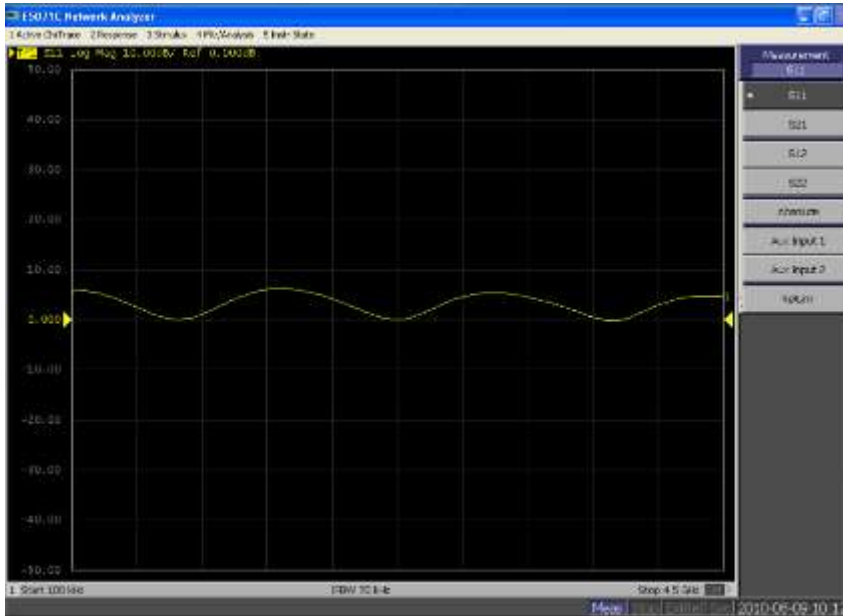
(2) Port-1 S11, Port-2 S22, Port-3 S33 or Port-4 S44 has trace distortion as shown as in below picture due to Mixer-IC infant transistor failure, though there is no cable or adapter connected to the port.

When the above symptom can be identified without connecting a cable or adapter to a port, then run the attached Mixer-IC diagnostic Test ***before performing Adjustment*** and if a Port results in FAIL, then replace the receiver board with the FAIL result.

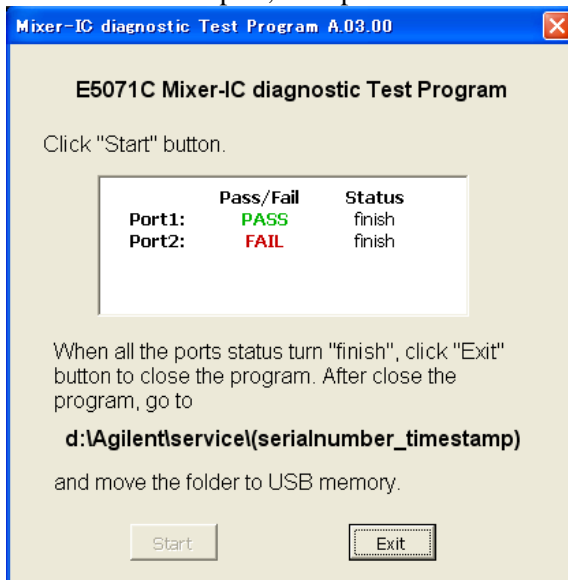
2-B.When either of the port results in **FAIL**, replace the failed port with a new receiver board.

2-B-1. Replace the receiver board. (See the E5071C Service Guide for more details)

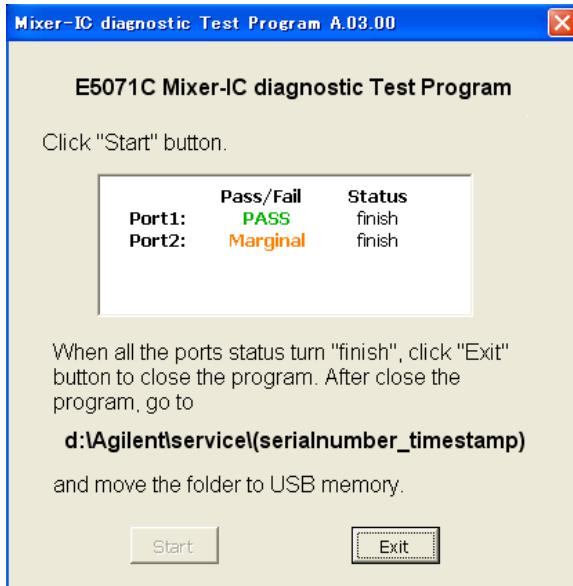
2-C.When either of the port results in **Marginal FAIL**, segregate the root cause whether it's due to bridge or not. If the Marginal FAIL port is not due to Bridge failure, Agilent considers it as Mixer-IC failure. Marginal FAIL is only shown on Option 2D5/2K5/4D5/4K5.

2-C-1. When the Marginal FAIL port is due to Mixer-IC failure, replace the receiver boards. (See the E5071C Service Guide for more details)

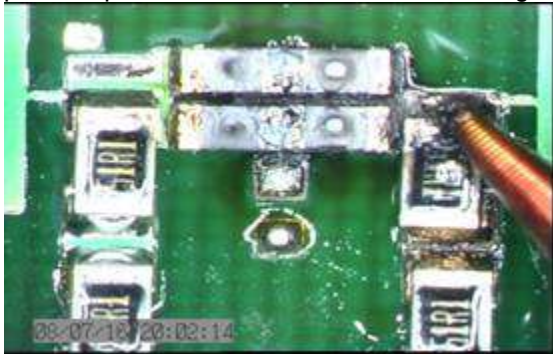
When Bridge Insertion Loss limit, Source Port Return Loss Limit or RF Port Return Loss is out of limit, please open the chassis and check the bridge circuit visually.

Note: When the bridge failure is shown, EOS(Excessive Over Stress) by customer is highly suspected. For this case, this service note is NOT applied.
