E5071C-19A

S E R V I C E N O T E

E5071C - ENA Series Network Analyzer, 9 kHz to 20 GHz

Boot up failure (2 LED issue) due to condensation

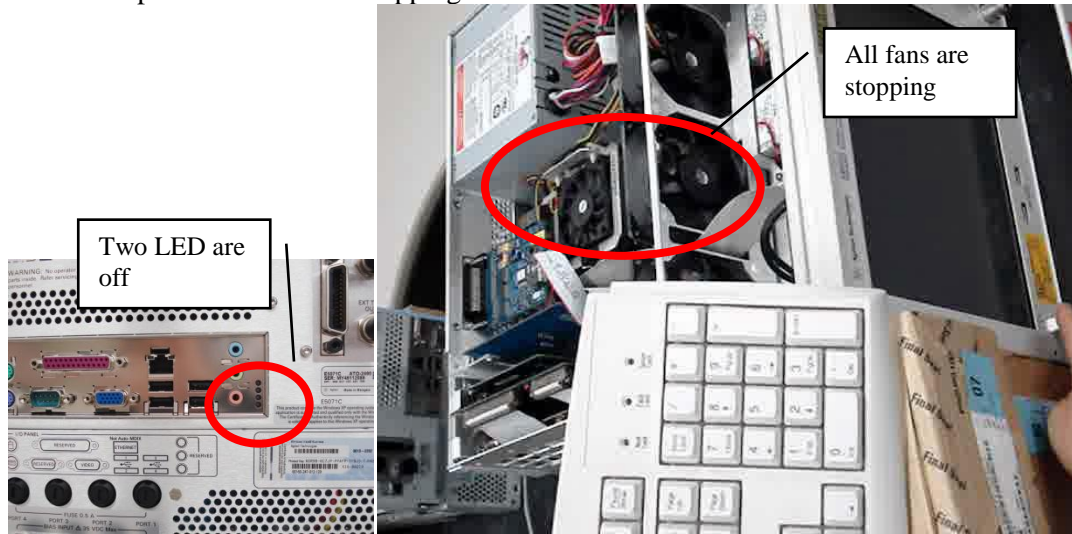
When front power switch was pushed after power toggle switch on the rear ATX power supply was turned on, E5071C looks to start with two LED's on the rear panel lighting and fans inside E5071C rotating. But after a few seconds, LED's and fans stop. No BIOS POST screen, OS selection screen nor Windows come out. E5071C is not able to start.

Figure-1 and Figure-2: Just after power button on the rear ATX power supply is turned on, no LED's on the rear panel with all fans stopping.

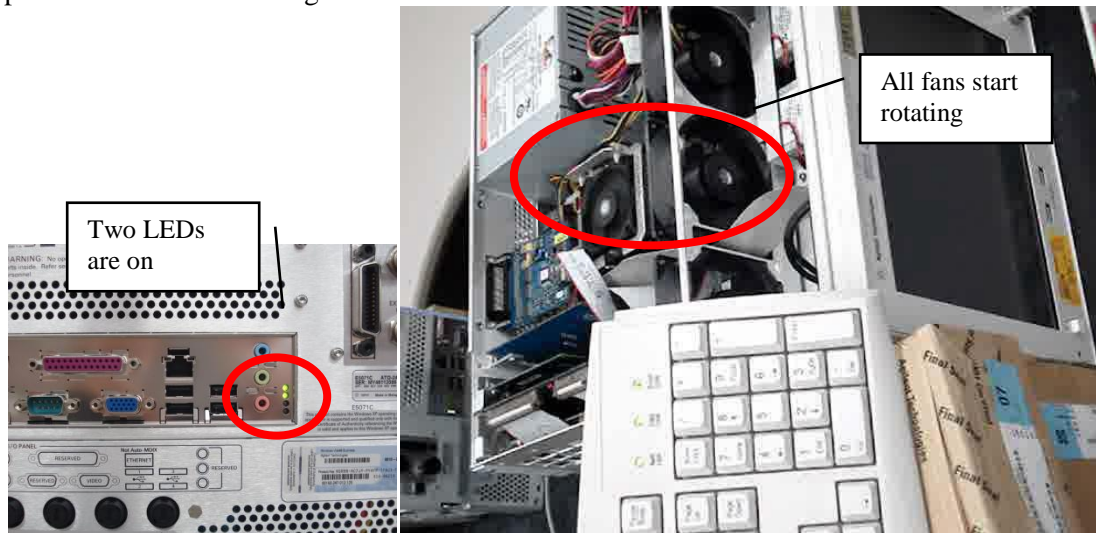
Figure-3 and Figure-4: Just after power switch on the front panel is turned on, two LED on the rear panel with all fans rotating.

If this symptom disappears when you heat up the instrument, Agilent considers it as condensation issue.

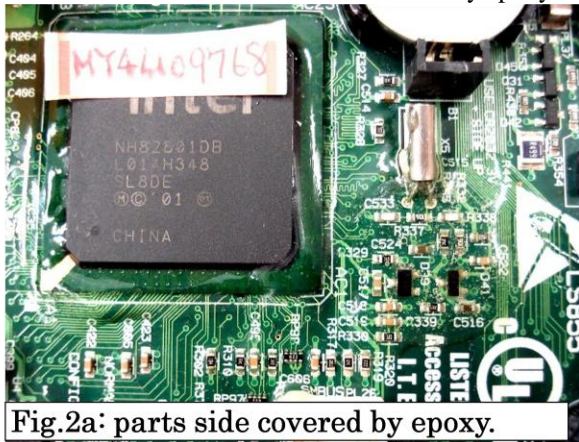
Fig.2a: parts side covered by epoxy.

2-7. Finished outlook of the board covered by epoxy resin is shown below.

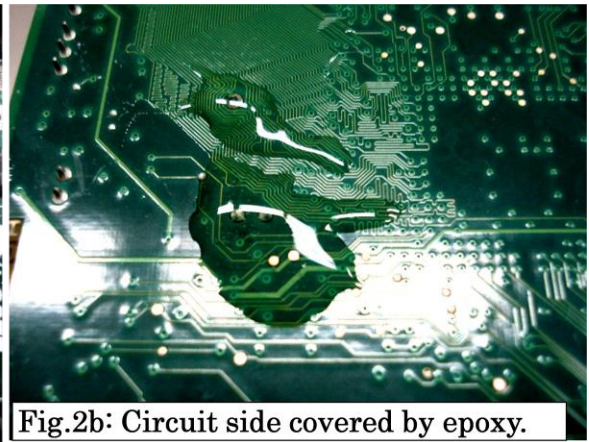
Fig.2b: Circuit side covered by epoxy.
