**E5515B-08C**

# **S E R V I C E                      N O T E**

## **E5515B Wireless Communications Test Set (8960 Series)**

### **Power-On DSP Initialization Failures Require Replacement of the DSP Assembly**

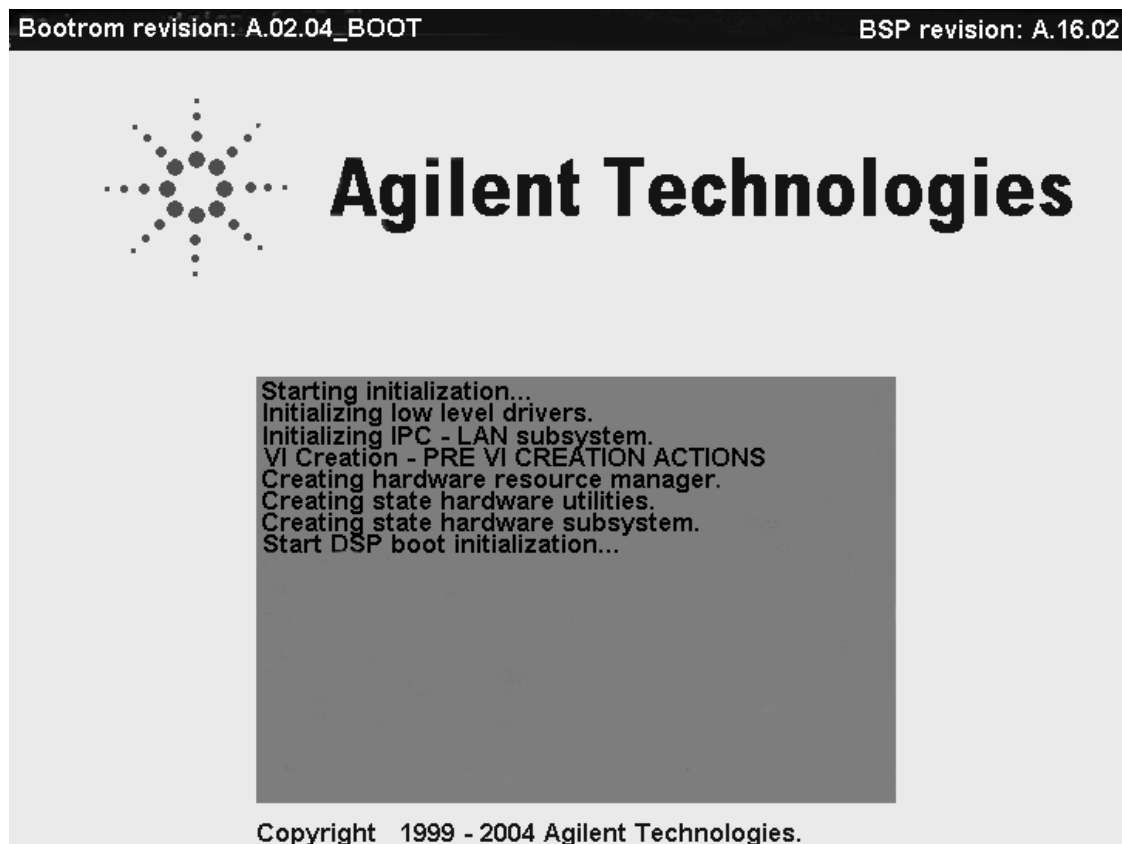
- **Figure 1** shows the typical point in the test set bootup process where the DSP fails to initialize. The bootup process may stop here and then re-boot, or will eventually complete the bootup process after multiple attempts to initialize the DSP assembly.

**Figure 1 – DSP initialization bootup failure during test set power-on.**

If the test set fails to bootup correctly, takes longer than normal to bootup, or displays messages noted below, replace the DSP Assembly using exchange repair kit E5515-69843. Verify that the test set boots up and operates normally. Re-calibration is not required.
