**E5515B-09B**

# **S E R V I C E                      N O T E**

## **E5515B Wireless Communications Test Set (8960 Series)**

### **Boot Up Failures at Power-On Require Replacement of 10 GB Hard Disk Drive (HDD)**

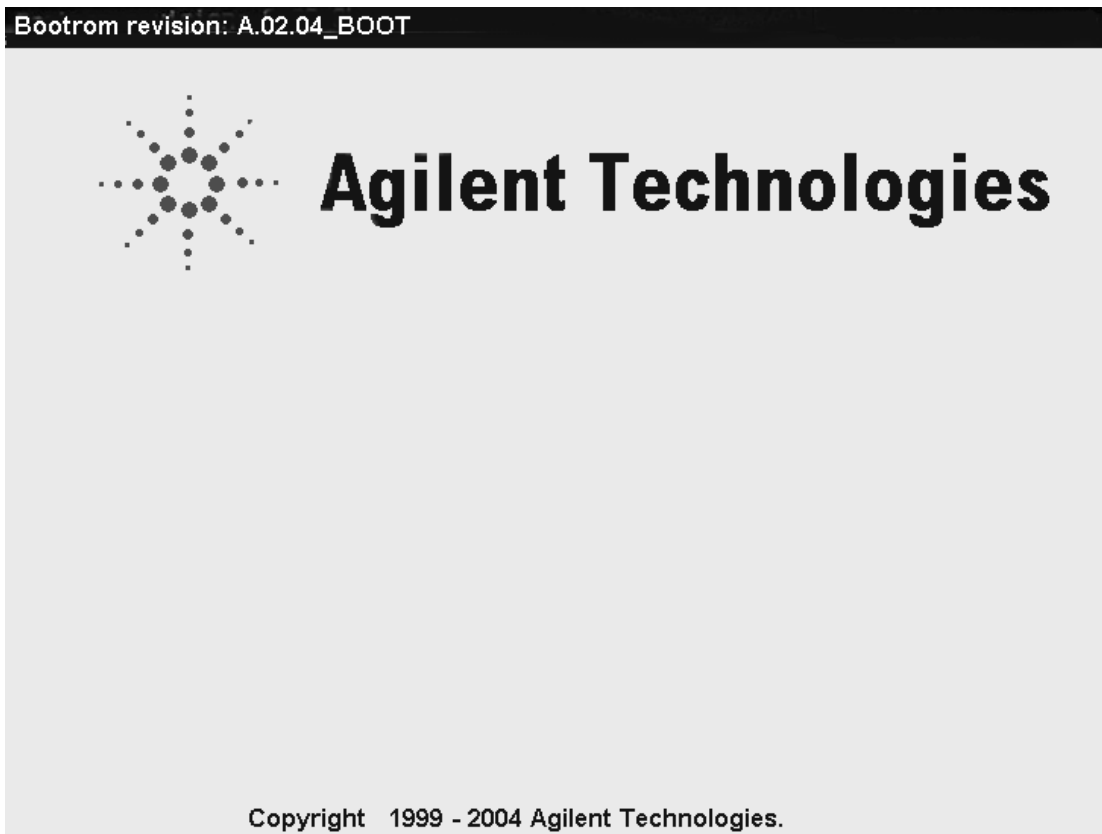
- **Figure 1** shows the typical point in the test set bootup process where the HDD fails to initialize. Note that the BSP Revision code is not displayed in the upper right corner of the display. A typical failing 10 GB HDD will show this screen intermittently in the first stages of failure.

A defective Channel Control chip on the HDD control circuitry is the main source of failures. This chip controls the read/write function to and from the HDD. The failure mechanism is accelerated with elevated ambient temperature and humidity (above 80 deg F and 80% relative humidity). Replacement HDDs (20 GB) have been re-designed to correct this problem.

**Figure 1 – HDD failure during test set power-on (BSP code not loaded from HDD to RAM).**

If the test set fails to bootup correctly replace the HDD using repair kit E5515-61833 (which uses a 20 GB HDD). You must provide the model number and serial number of the test set when placing an order for this repair kit.
