**E6198A-04****S E R V I C E N O T E**Supersedes:  
NONE

E6198A Switch Load Unit (SLU)  
- used in E8780B, E8781A, E8786B, and E2240A

Enhancement solution is available to SLU backplane discoloration issue by  
removing the preload resistors from backplane.

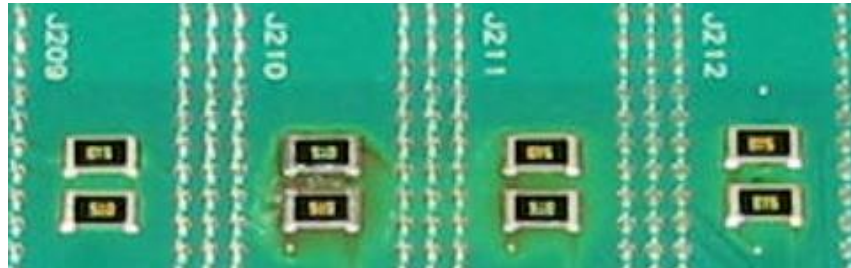
Agilent has recently received some feedbacks regarding the discoloration marks seen on the SLU backplane (E6170-66502) near the area of preload resistors (see Figure 1). As proactive response to the feedbacks, we have done the root cause analysis and safety evaluation on the backplane. The result shows that this discoloration mark was due to heating from the resistors and it will NOT cause any safety concerns.

Figure 1. Discoloration mark on the SLU backplane near the area of preload resistors.

Despite the SLU backplane is still safe to be used, Agilent would like to offer an enhancement solution to the matter by removing the preload resistors from the backplane. The removal will bring the following benefits to the users (1) prevent the discoloration from further deteriorating, (2) extend the life span of the backplane, and (3) increase the current consumption bandwidth of internal power supply.
