**E6473A-01**

# S E R V I C E                      N O T E

## **E6473A Network Optimization Solution-Hardware Used in E6474A Wireless Network Optimization Platform ("Nitro" Drive-test Family)**

**Use of Agilent phone cables in "Direct Connect" configuration may cause communication issues with E6474A application.**

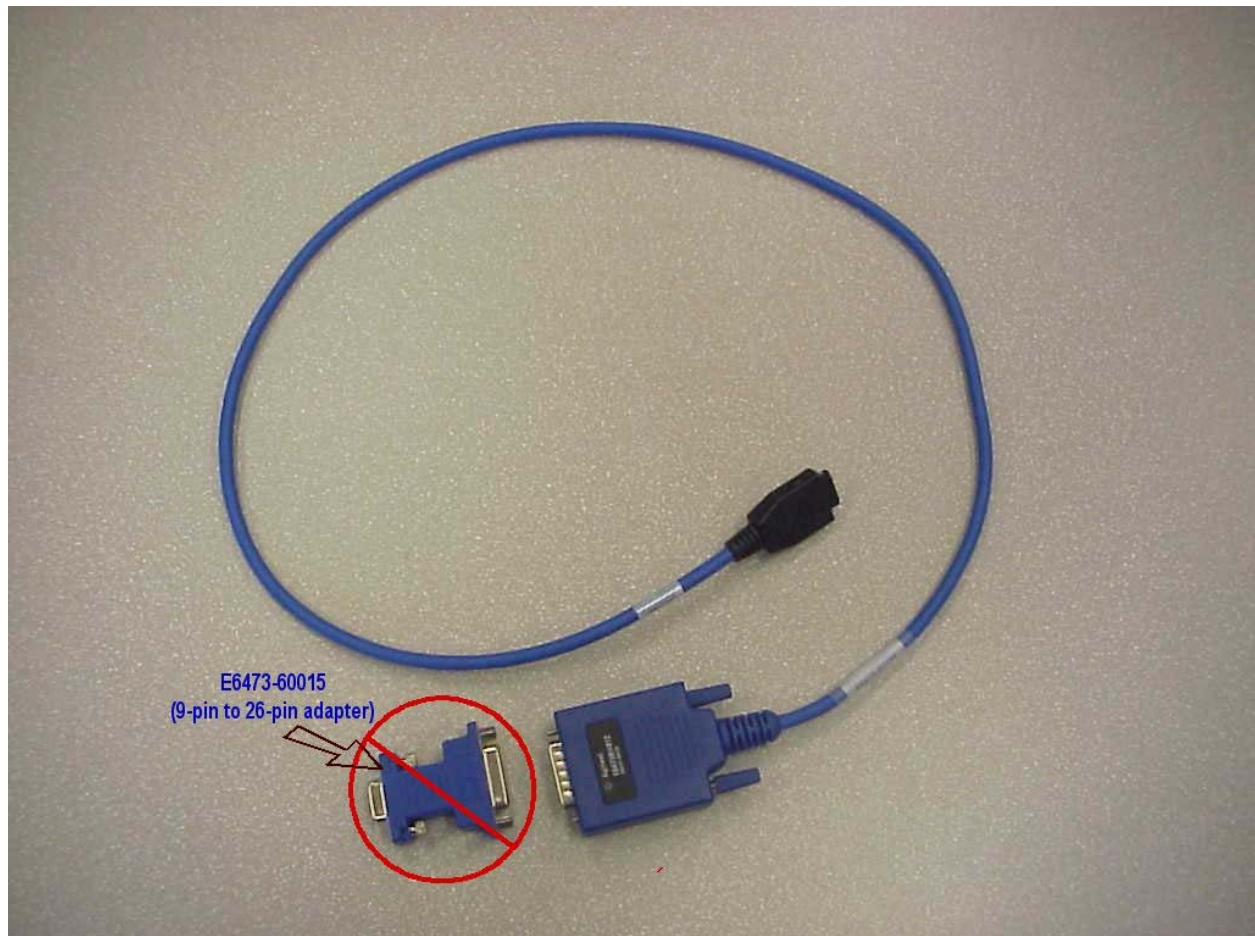
**Figure 1**

In some cases where phones are connected directly to the data collection PC's RS-232 connection using an Agilent phone interface cable and DB-25 to DB-9 adapter, the data collection PC\* COM port may not provide adequate power for the Agilent phone interface cable and user's test phones. The likelihood of occurrence is dependant on the PC used, as well as quantity and type of phone(s) connected in this manner. This problem will not occur in hub-connected phones, and has not been observed when OEM cables have been used.

For those customers reporting phone-charging or communication COM error problems in a Direct Connect configuration, substitution of an OEM cable is recommended. Alternatively, the connection should be made via a direct connect hub (E6473A-010 and E6473A-020), and must be used if an OEM cable is not available.
