E8257D-38

# Information Only Service Note

## E8257D Analog Signal Generator

**The Problem** – Unsuccessful firmware upgrade using the Firmware Upgrade Assistant in IP address connection

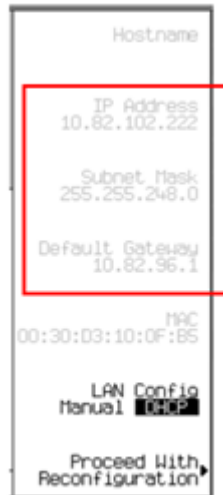
Unsuccessful firmware upgrade on the instrument you are trying to upgrade when using the Firmware Upgrade Assistant (FUA) by IP connectivity.

- a. Go to **Utility > GPIB/RS-232 LAN > LAN setup** and that the LAN Config is set to **DHCP**. Copy down the IP Address, Subnet Mask and Default Gateway.
