E8357A-02F

S E R V I C E N O T E

E8357A PNA Series RF Network Analyzers

Serial Numbers: 00000000 thru 46999999

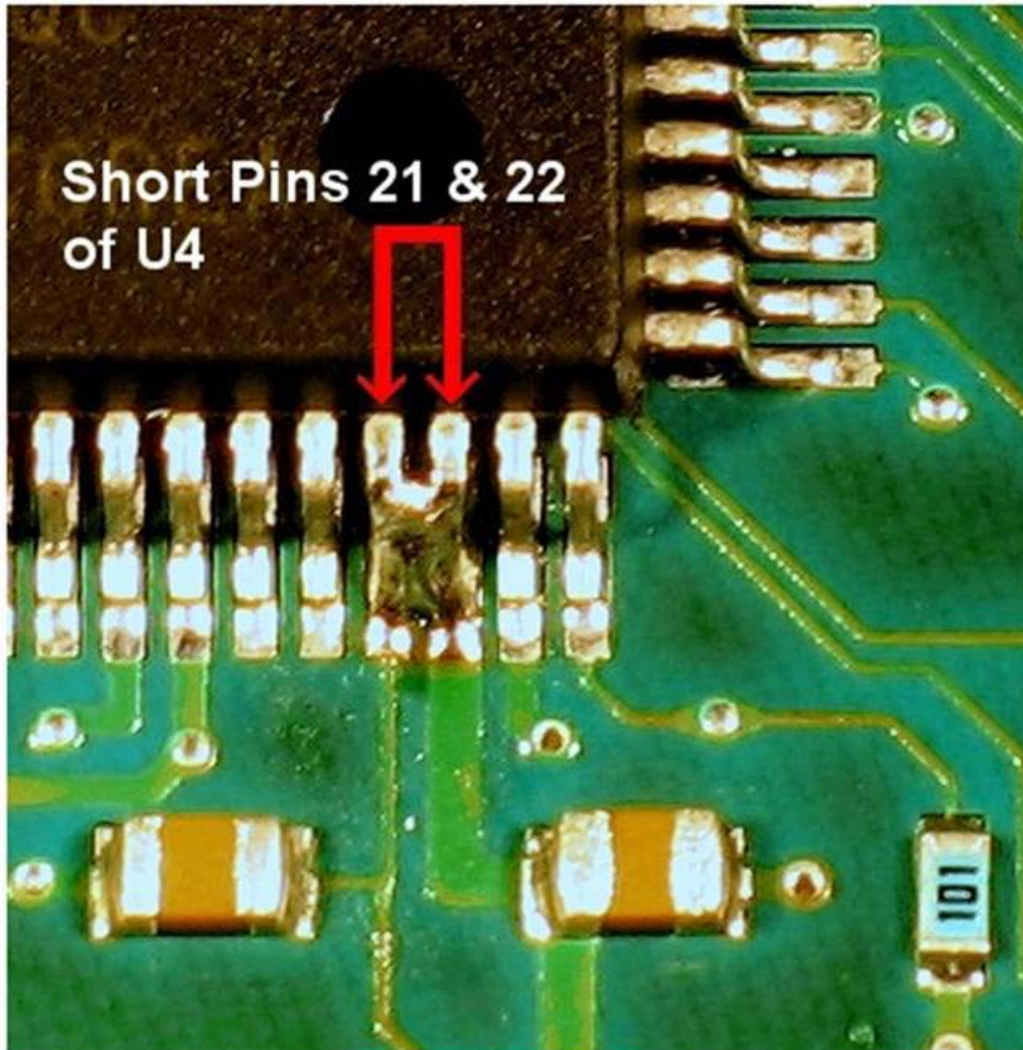
Both intermittent problems have been traced to an incorrect voltage applied to a pin on the U4 IC.

Carefully solder pins 21 and 22 together on U4. Refer to Figure 2 for the exact location. Use care so that no other pins are shorted. Use of a very fine tip soldering iron is recommended and a large work-task magnifying glass is very helpful.
