**S E R V I C E****N O T E**

Supersedes:  
E8362A-01A

## E8362A PNA Series RF Network Analyzers

Serial Numbers: 00000000 thru 46999999

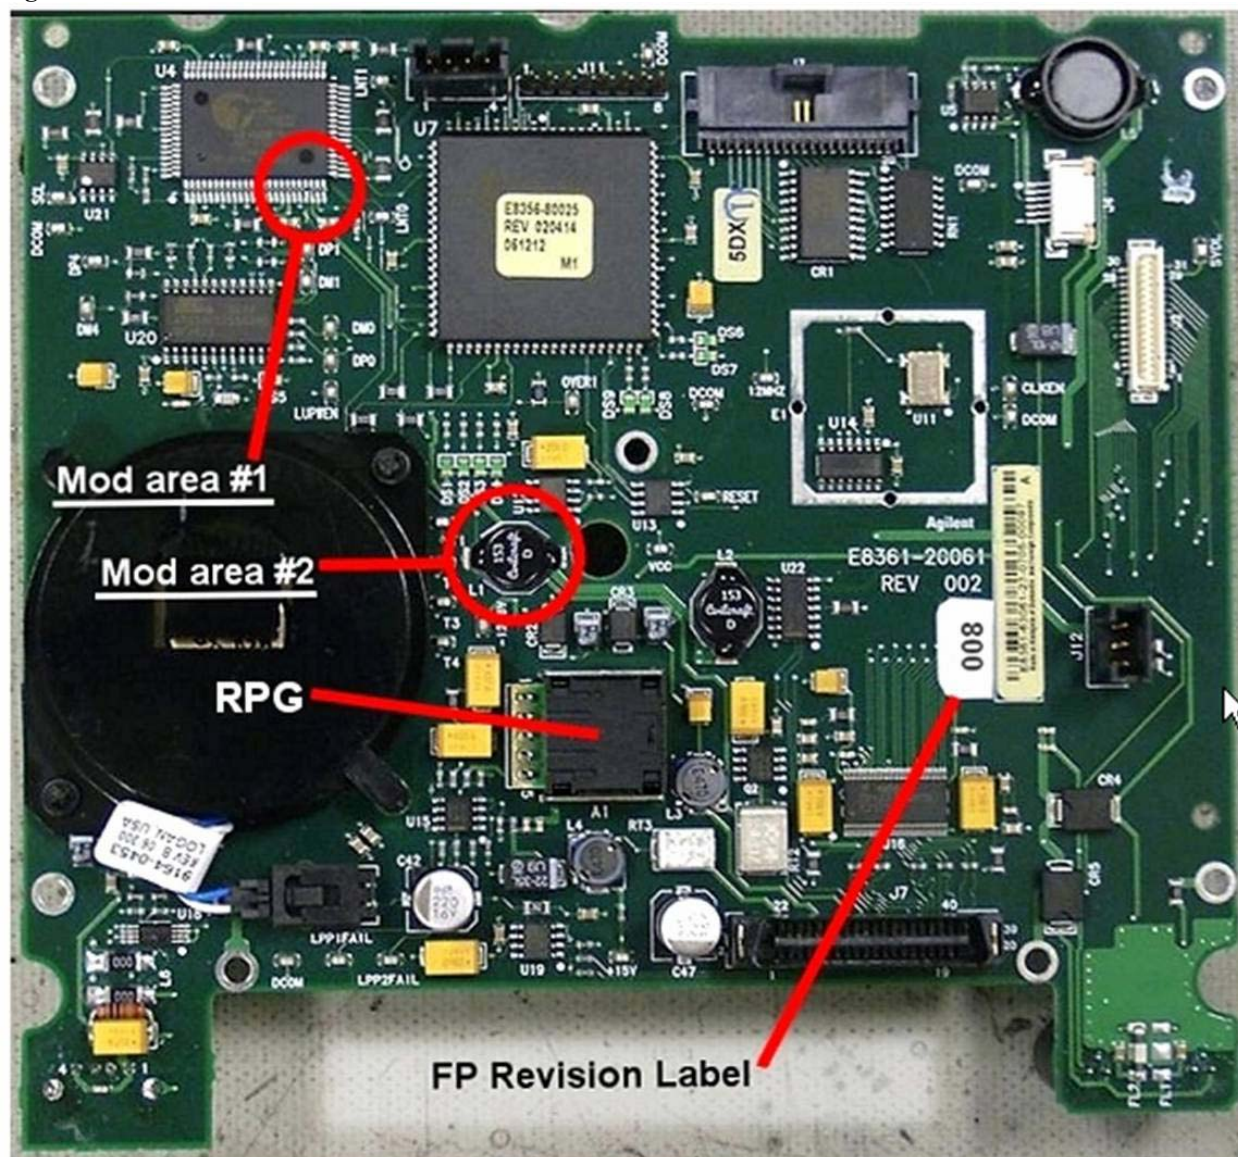
Refer to Figure 1 for the two modification areas to be addressed. Note that while this picture happens to show the FPI board completely removed from the front frame assembly, this is not necessary to perform the required modifications.

- Modification #1 consists of shorting two pins of U4 together with a small amount of solder.
- Modification #2 consist of removing L1.

Unsolder and completely remove the black surface mount inductor L1 from the front panel assembly board. This is no longer needed and can be discarded.

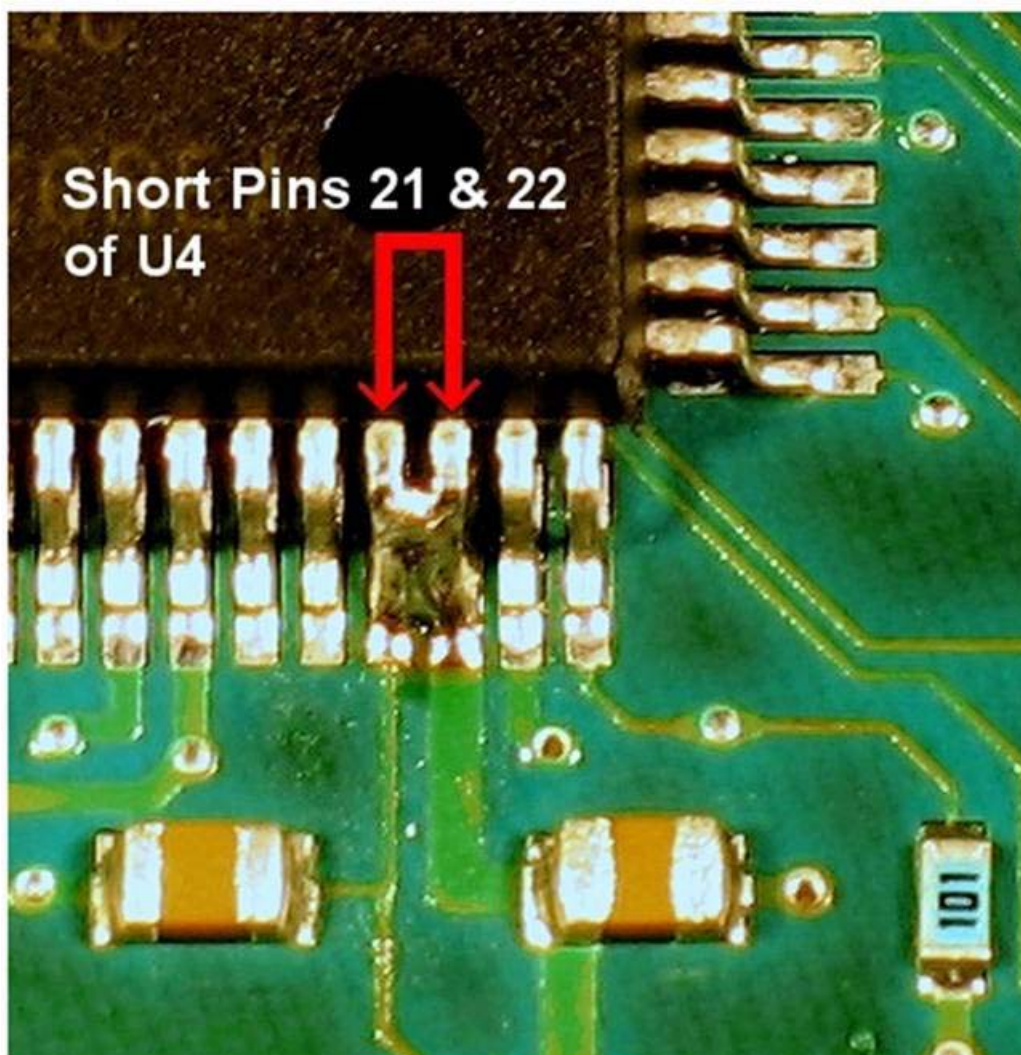
FPI boards E8356-60209 and the older E8356-60029 were both identified as causing a serious “won’t boot” condition and a USB signal integrity issue. These issues were noticed in production as well as service centers. The booting issue was due to a tantalum capacitor (C58, 4.7uF, and 50V) reversed biased at 10 percent of its rated voltage. Both issues were fixed with a board layout change of the E8361-63061, revisions 001 to 007 FPI boards. Older E8361-63061 revision 008 FPI boards were identified as having an intermittent front panel keyboard and RPG lockup problems. This problem has been traced to an incorrect voltage applied to a pin on the U4 IC.

Carefully solder pins 21 and 22 together on U4. Refer to Figure 2 for the exact location. Use care so that no other pins are shorted. Use of a very fine tip soldering iron is recommended and a large work-task magnifying glass is very helpful.
