E8362A-02A

**S E R V I C E N O T E**

E8362A PNA Microwave Network Analyzers

June 9, 2008

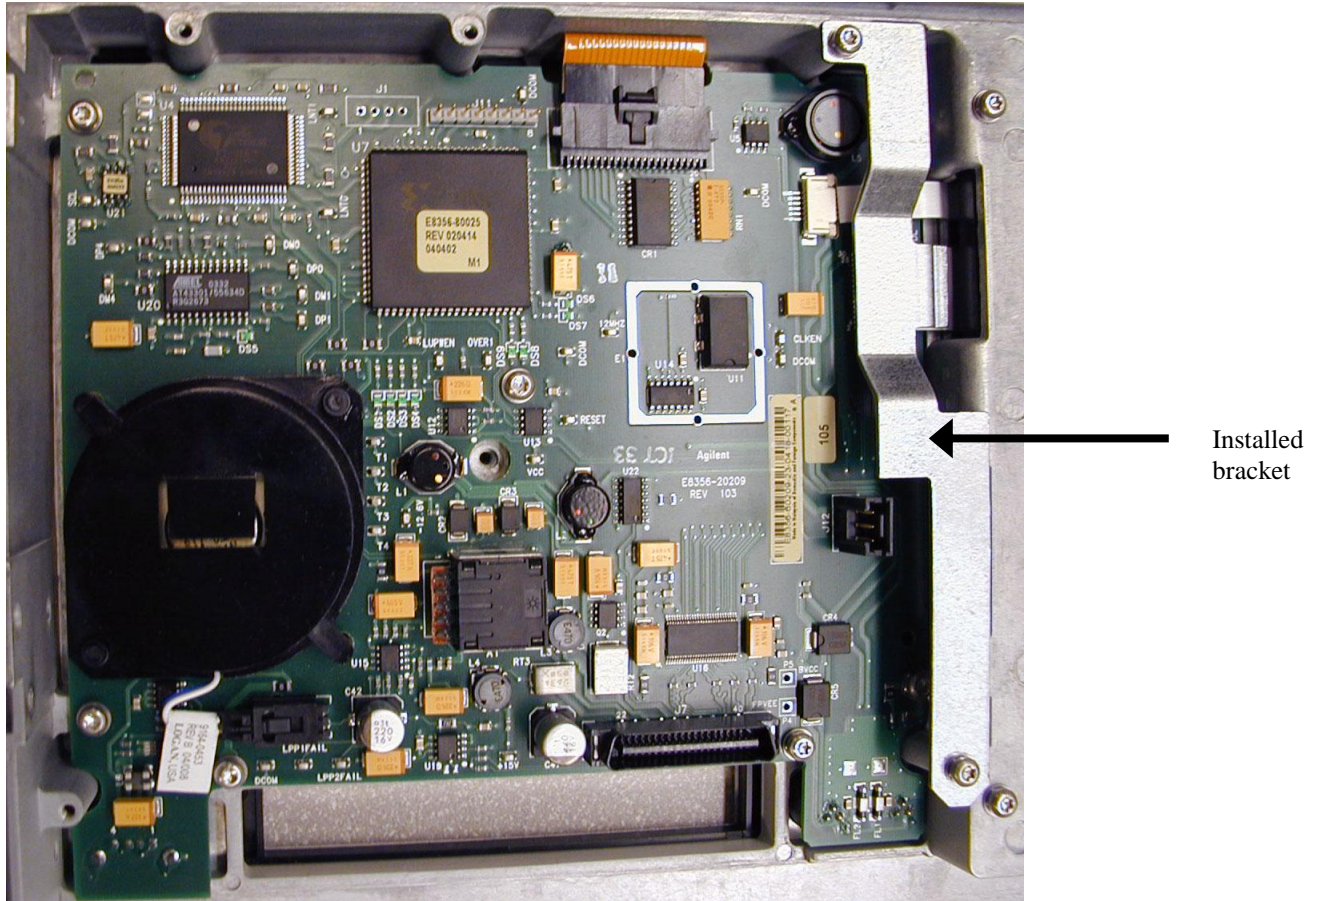
**Figure 2: A3 Front Panel Interface Board Assy with the Bracket Installed**

1. Refer to Figure 1 in this document:
  - Press down firmly on the ribbon cable's black connector.
  - Locate the two tapped holes for the bracket screws.
2. As shown in Figure 2 in this document, position the bracket so that its holes line-up with the two holes you located in the previous step.
3. Hand-start the two screws, and then torque both to 9 in-lbs.
4. Reinstall the PNA Front Panel by following the Service Guide instructions in the "Replacement Procedure." This is located on the same page as the "Removal Procedure" used previously in step 7.
