E8362B-01C

S E R V I C E N O T E

E8362B PNA Series RF Network Analyzers

Serial Numbers: 00000000 thru 46999999

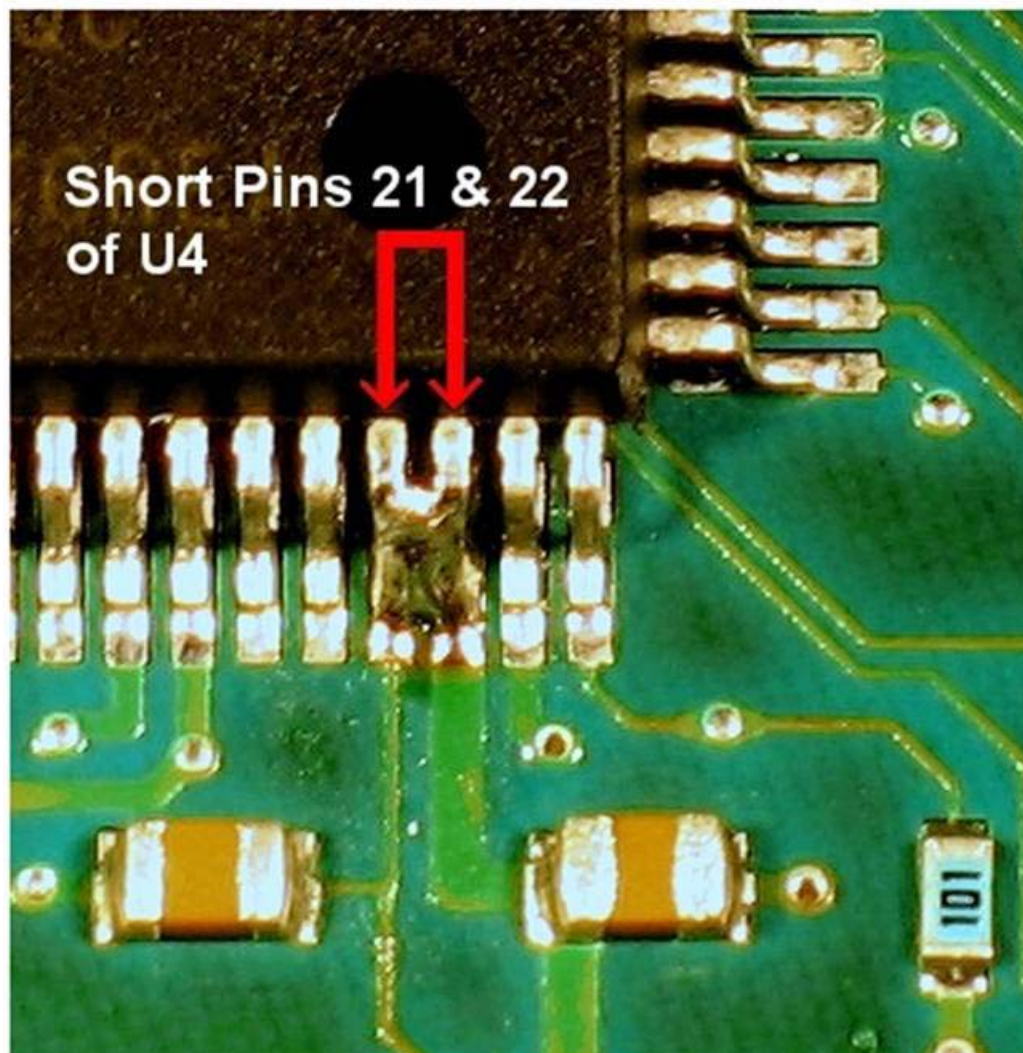
Both intermittent problems have been traced to an incorrect voltage applied to a pin on the U4 IC.

Carefully solder pins 21 and 22 together on U4. Refer to Figure 2 for the exact location. Use care so that no other pins are shorted. Use of a very fine tip soldering iron is recommended and a large work-task magnifying glass is very helpful.
