**E8362B-02**

# **S E R V I C E N O T E**

## **E8362B PNA Microwave Network Analyzers**

**Serial Numbers: ALL**

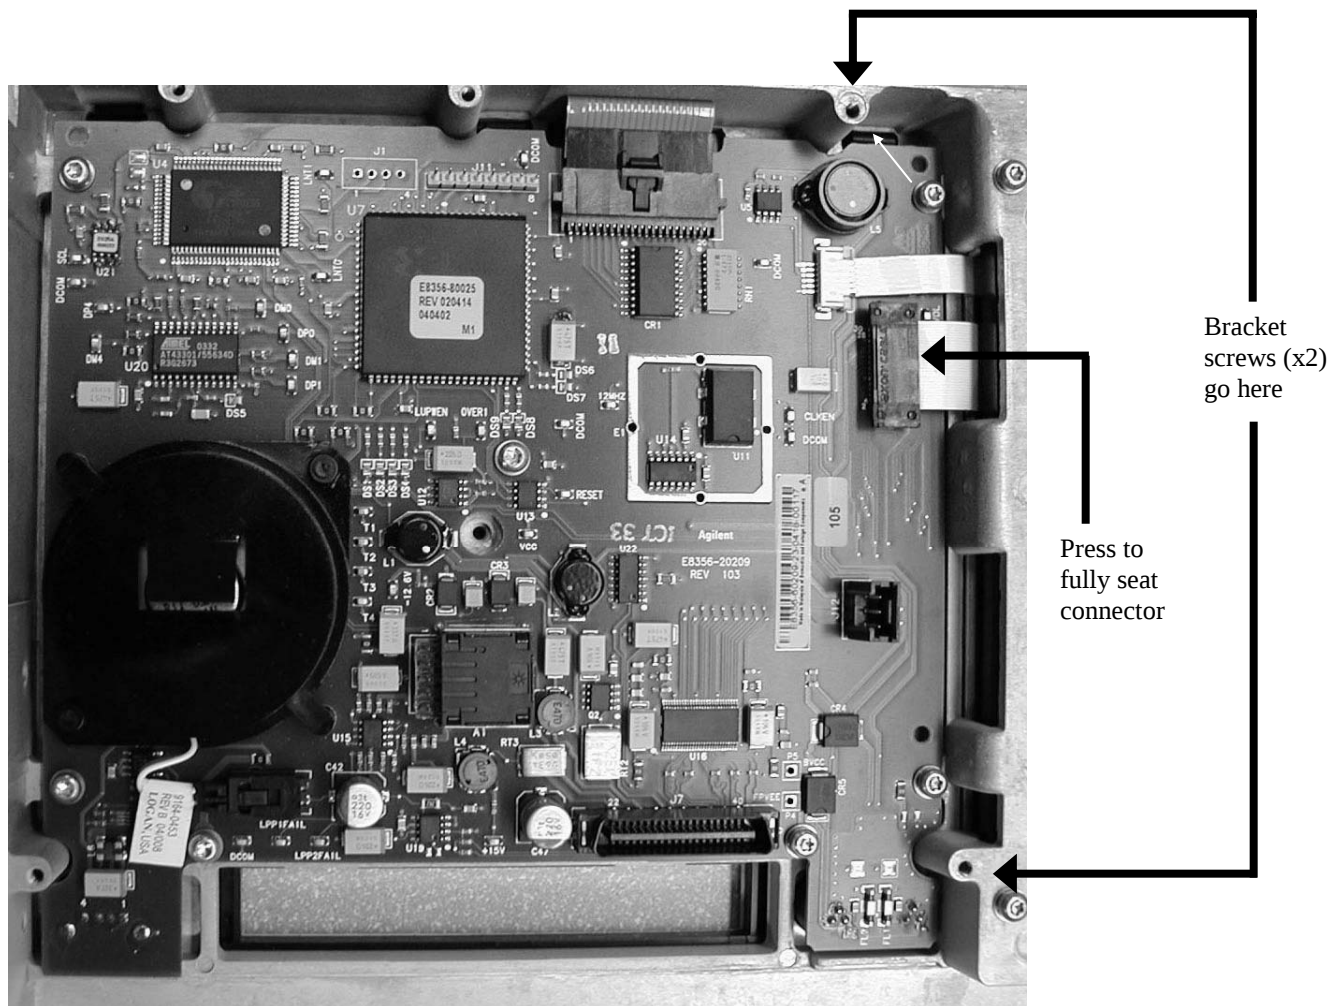
**Figure 1: A3 Front Panel Interface Board Assy without the Bracket**

A connector of the ribbon cable (Agilent part number 8120-8409) that joins the front panel display to the front panel interface board can loosen, causing a display failure, unless a new bracket is installed. Because the failure rate has been very low, it is recommended that the bracket be installed only when there is an additional reason to remove the PNA front panel.

1. Refer to Figure 1 in this document:
  - Press down firmly on the ribbon cable's black connector.
  - Locate the two tapped holes for the bracket screws.
2. As shown in Figure 2 in this document, position the bracket so that its holes line-up with the two holes you located in the previous step.
3. Hand-start the two screws, and then torque both to 9 in-lbs.
4. Reinstall the PNA Front Panel by following the Service Guide instructions in the "Replacement Procedure." This is located on the same page as the "Removal Procedure" used previously in step 7.
