E8362B-02A

**S E R V I C E N O T E**

E8362B PNA Microwave Network Analyzers

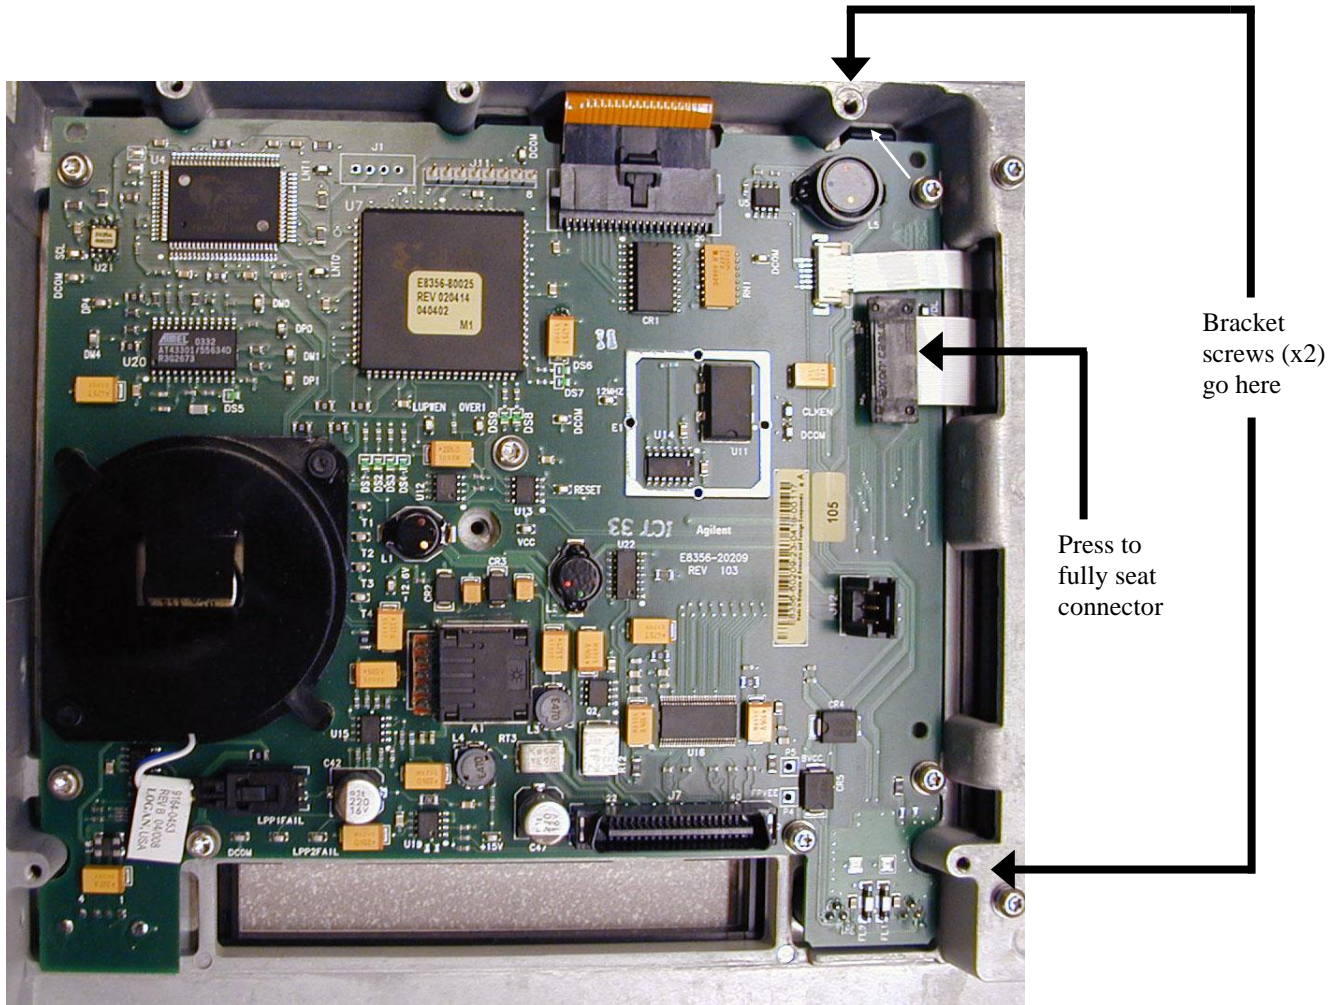
**Figure 1:** A3 Front Panel Interface Board Assy without the Bracket

A connector of the ribbon cable (Agilent part number 8120-8409) that joins the front panel display to the front panel interface board can loosen, causing a display failure, unless a new bracket is installed. Because the failure rate has been very low, it is recommended that the bracket be installed only when there is an additional reason to remove the PNA front panel.

1. Refer to Figure 1 in this document:
  - Press down firmly on the ribbon cable's black connector.
  - Locate the two tapped holes for the bracket screws.
2. As shown in Figure 2 in this document, position the bracket so that its holes line-up with the two holes you located in the previous step.
3. Hand-start the two screws, and then torque both to 9 in-lbs.
4. Reinstall the PNA Front Panel by following the Service Guide instructions in the "Replacement Procedure." This is located on the same page as the "Removal Procedure" used previously in step 7.
