# E8362BH85-01

# S E R V I C E N O T E

## E8362BH85 PNA Series RF Network Analyzers

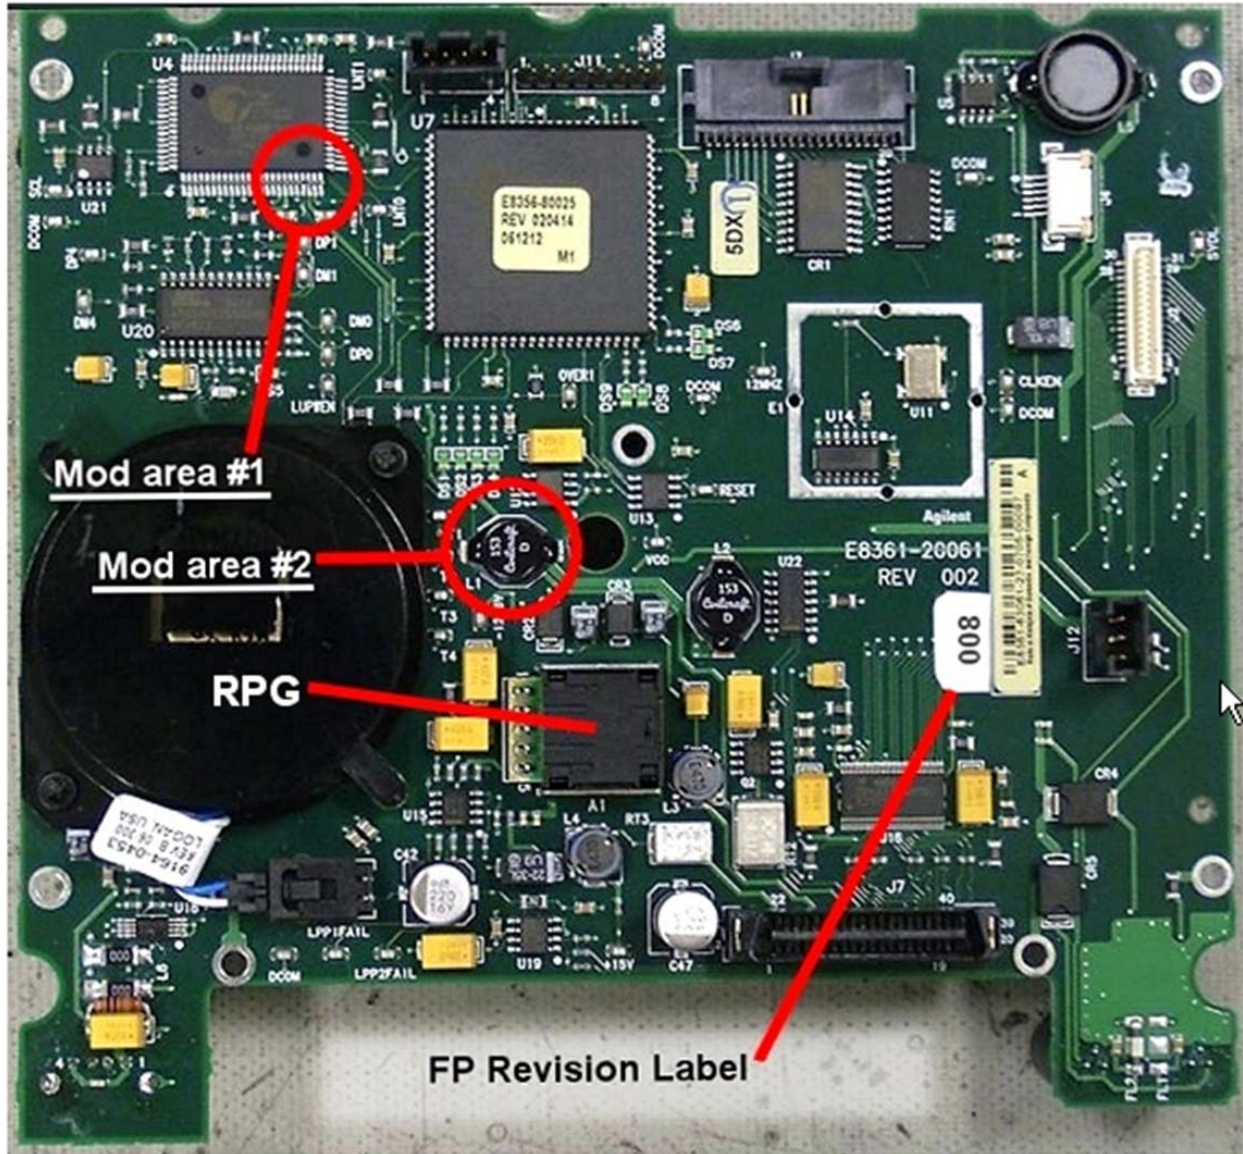
Refer to Figure 1 for the two modification areas to be addressed. Note that while this picture happens to show the FPI board completely removed from the front frame assembly, this is not necessary to perform the required modifications.

- Modification #1 consists of shorting two pins of U4 together with a small amount of solder.
- Modification #2 consist of removing L1.

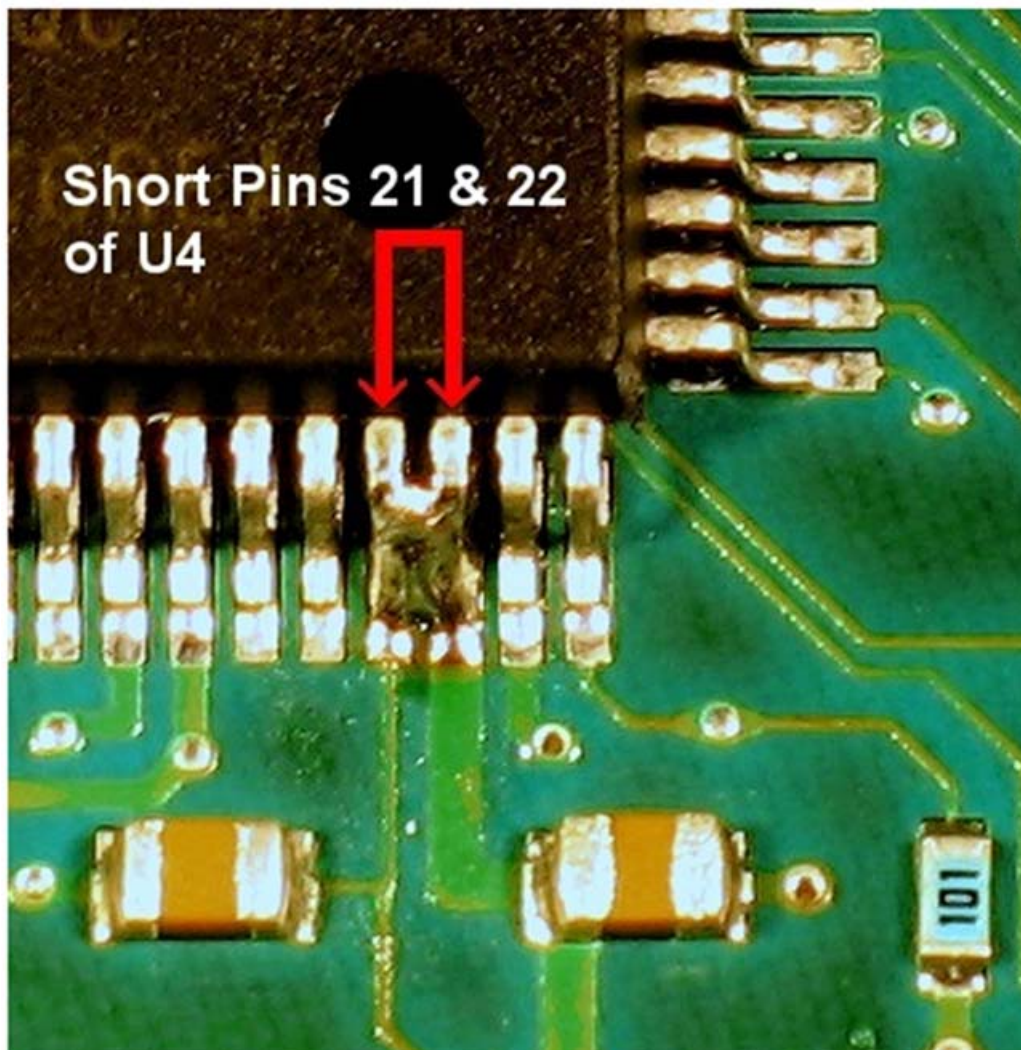
**Figure 2**

Both intermittent problems have been traced to an incorrect voltage applied to a pin on the U4 IC.

Carefully solder pins 21 and 22 together on U4. Refer to Figure 2 for the exact location. Use care so that no other pins are shorted. Use of a very fine tip soldering iron is recommended and a large work-task magnifying glass is very helpful.
