E8362BH85-05

S E R V I C E N O T E

E8362BH85 PNA Series RF Network Analyzers

Replace Inverter board (0950-3379) due to faulty component.

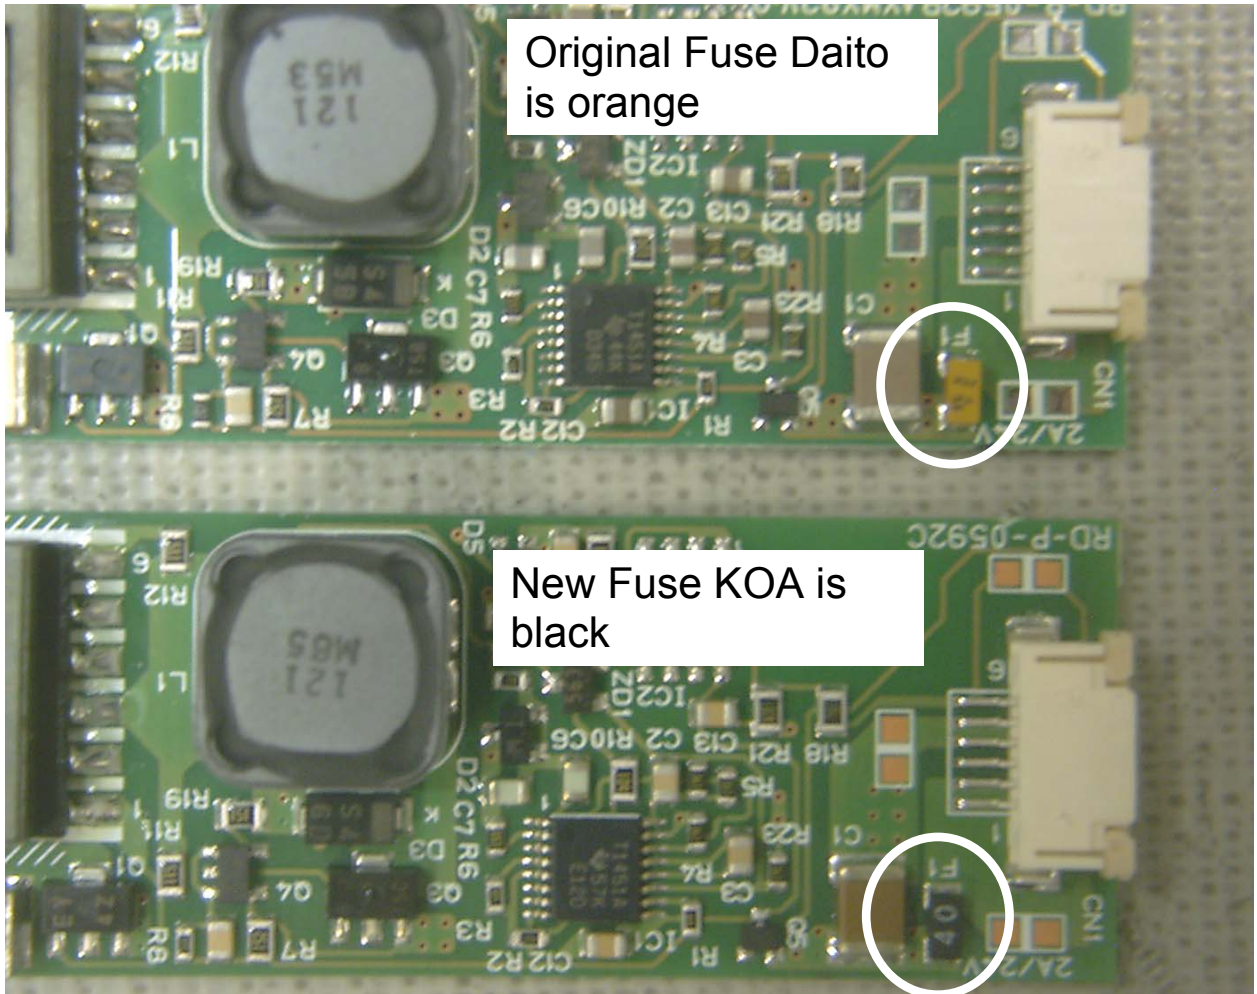
The original fuse (see photo) in the DC/AC Inverter board (p/n 0950-3379) is prone to failure in normal use.

Replace the Inverter board with a board containing the new fuse (see photo).
