E8363BH85-03A

S E R V I C E N O T E

E8363BH85 PNA Microwave Network Analyzers

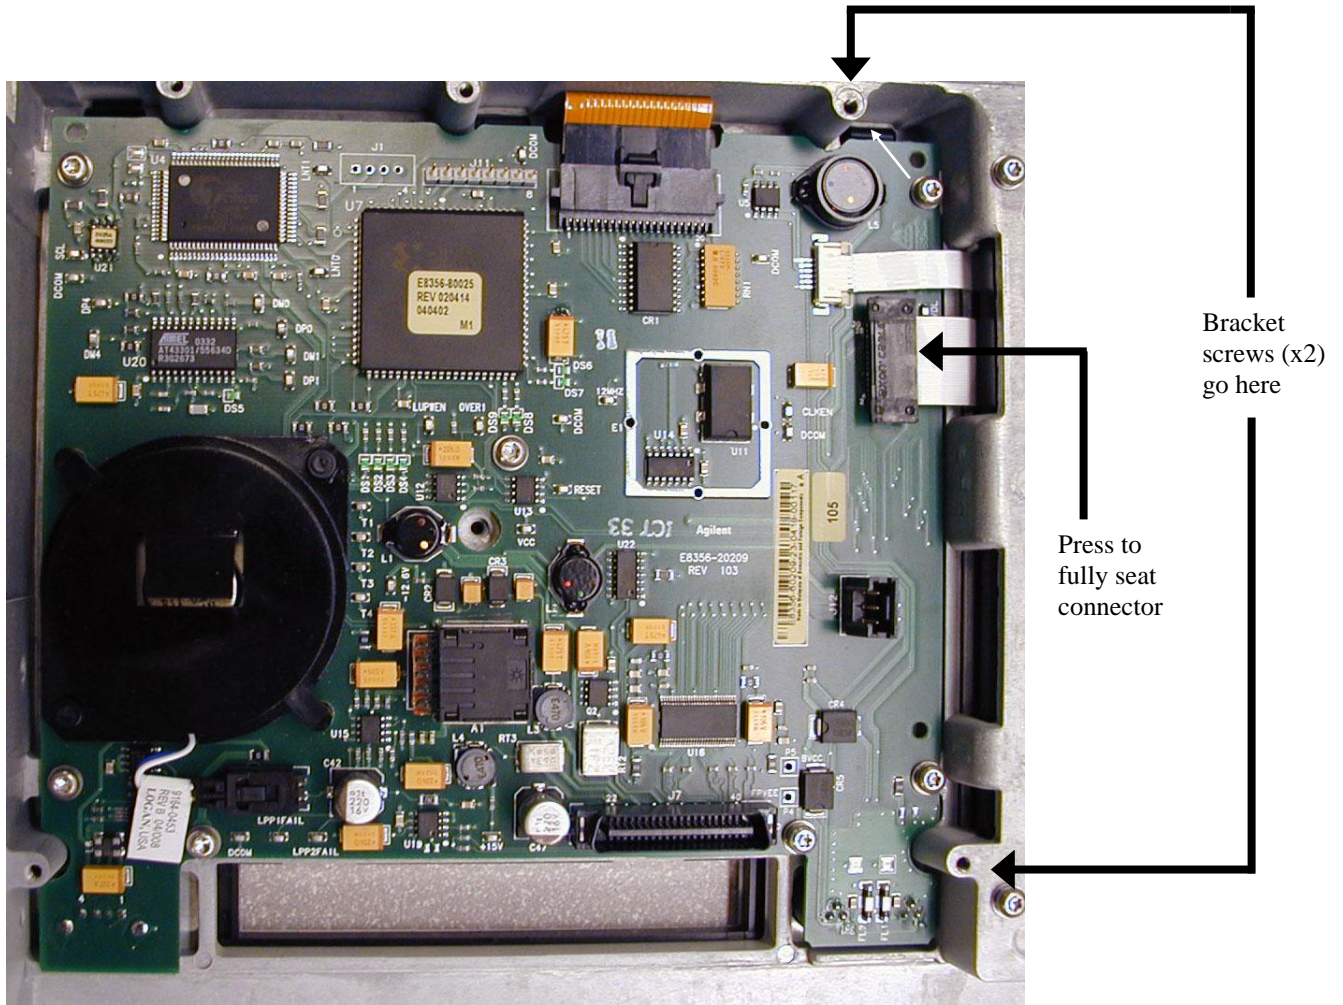
A connector of the ribbon cable (Agilent part number 8120-8409) that joins the front panel display to the front panel interface board can loosen, causing a display failure, unless a new bracket is installed. Because the failure rate has been very low, it is recommended that the bracket be installed only when there is an additional reason to remove the PNA front panel.

Figure 1: A3 Front Panel Interface Board Assy without the Bracket

1. Refer to Figure 1 in this document:
 - Press down firmly on the ribbon cable's black connector.
 - Locate the two tapped holes for the bracket screws.
2. As shown in Figure 2 in this document, position the bracket so that its holes line-up with the two holes you located in the previous step.
3. Hand-start the two screws, and then torque both to 9 in-lbs.
4. Reinstall the PNA Front Panel by following the Service Guide instructions in the "Replacement Procedure." This is located on the same page as the "Removal Procedure" used previously in step 7.
