# E8364B-06A

# S E R V I C E N O T E

## E8364B PNA Series RF Network Analyzers

**Replace Inverter board (0950-3379) due to faulty component.**

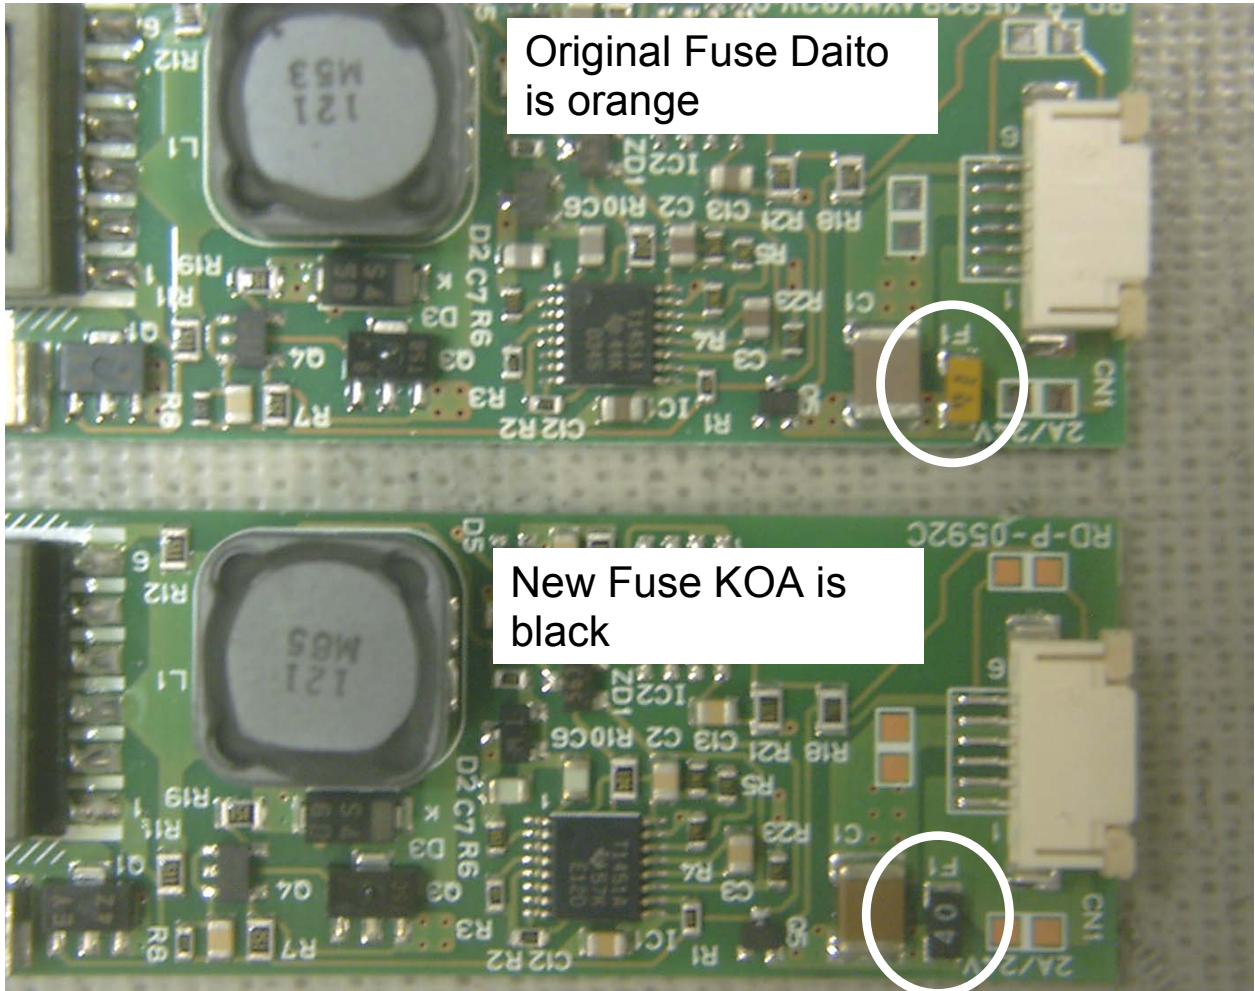
The original fuse (see photo) in the DC/AC Inverter board (p/n 0950-3379) is prone to failure in normal use.

Replace the Inverter board with a board containing the new fuse (see photo).
