E8364C-02A

S E R V I C E N O T E

E8364C PNA Microwave Network Analyzers

A new touchscreen display inverter shield is available to improve PNA noise floor performance.

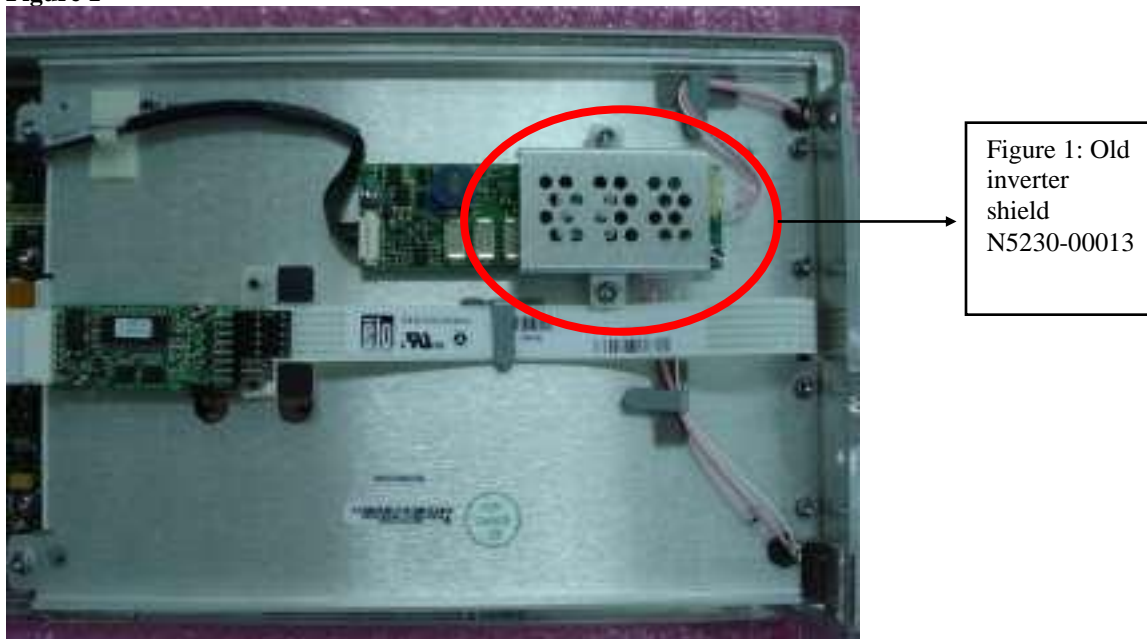
Some PNA C-models may exhibit poor noise floor performance caused by inverter shield N5230-00013.

If a PNA C-model exhibits poor noise performance, examine the inverter shield to see if it is the N5230-00013. Figure 1 shows that the N5230-00013 shield has vent holes. If present, replace the old shield (N5230-00013) with the new shield (N5230-00017) as per the following instructions.

7. Follow the instructions in the subsection "Removal Procedure."
8. Once the front panel has been removed from the PNA, place it on a flat surface. Figure 1 shows that the N5230-00013 inverter shield has vent holes.
