E8663B-04

S E R V I C E N O T E

E8663B Analog Signal Generator

Intermittent power supply shutdown

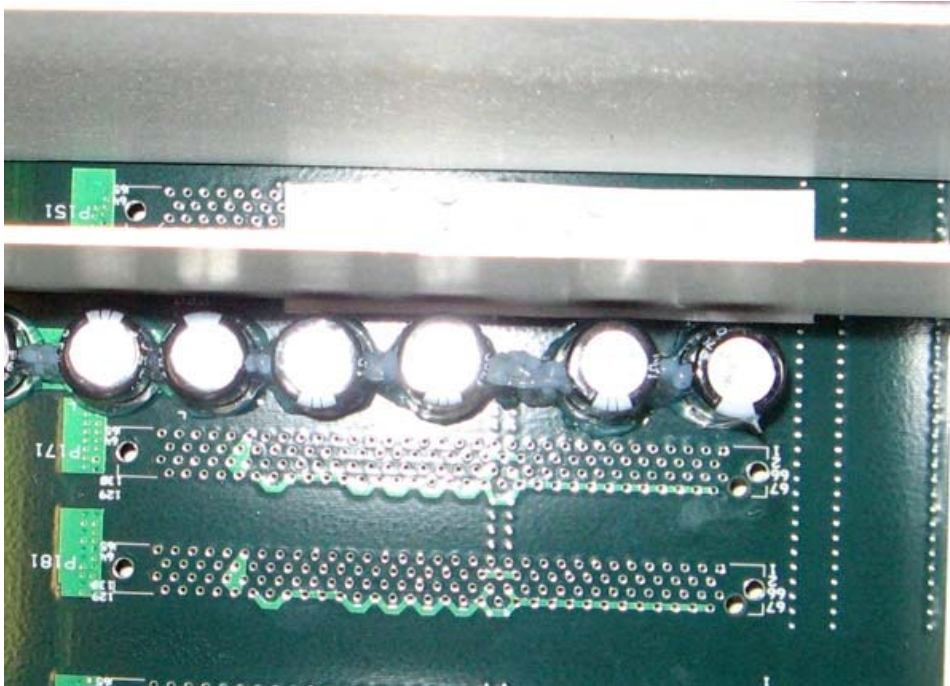
Figure 4

A via on the E8251-60441 mother board may intermittently short to the card cage causing the power supply to reset or shut down. The intermittent short does not cause permanent damage.

7. Position the insulator so that it can be seen on both sides of the divider and that it covers the area under the divider between the 4 larger capacitors on the right side as shown in Figure 4.
