E8663D-01

S E R V I C E N O T E

E8663D Analog Signal Generator

Intermittent CPU boot-up and/or No display

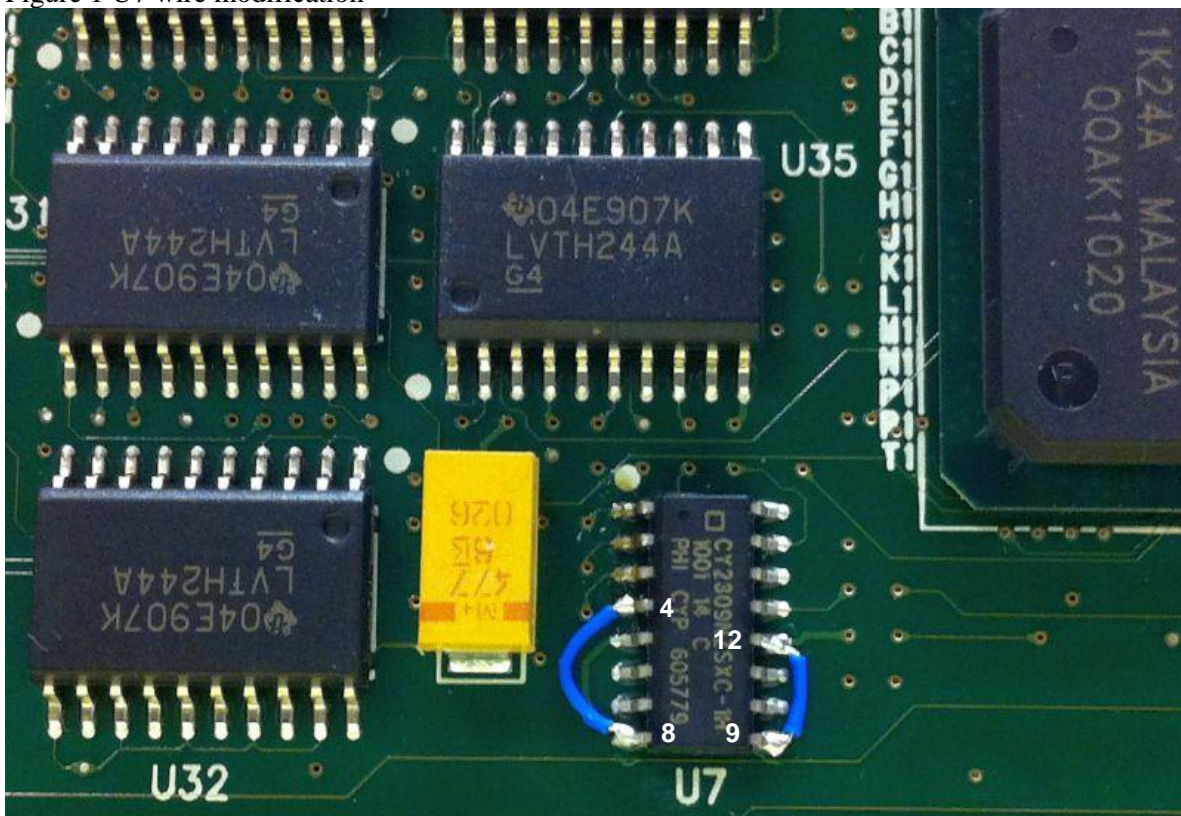
Figure 1 U7 wire modification

The clock buffer, U7 on the CPU board (E8251-60006 or E8251-60661), may cause intermittent boot up and/or no display when the instrument is powered up. It is recommended that this modification is performed on any instrument within the serial numbers above that exhibits an intermittent boot-up and/or a blank display.

Using the appropriate soldering technique and ESD station, perform a modification on the U7 circuit on the CPU board. Connect U7 pin 8 to 3.4V (wire pin 8 to pin 4) and connect U7 pin 9 to DCOM (wire pin 9 to pin 12).

1. Refer to E8257D Service Guide for the A18 CPU removal procedure.
2. Refer to Figure 1 for U7.
3. Use 30 AWG wire for wiring pin 8 to pin 4, and pin 9 to pin 12 per Figure 1.
4. Re-install CPU and cover.
5. Run self test.
6. No calibration is required.
