E8663D-13

# Information Only Service Note

## E8663D RF Analog Signal Generator

**The Problem** – Unsuccessful firmware upgrade using the Firmware Upgrade Assistant in IP address connection

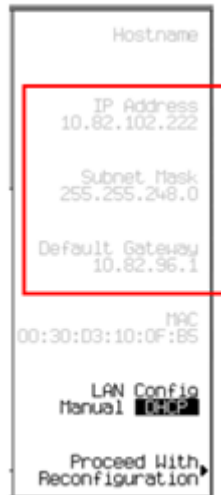
Unsuccessful firmware upgrade on the instrument you are trying to upgrade when using the Firmware Upgrade Assistant (FUA) by IP connectivity.

- a. Go to **Utility > GPIB/RS-232 LAN > LAN setup** and that the LAN Config is set to **DHCP**. Copy down the IP Address, Subnet Mask and Default Gateway.
