E9902G-01

Modification Recommended Service Note

Keysight i3070 Series 6 In-Circuit Test System

Intermittent T3610 errors during Diagnostics (DGN) on certain batches of pin cards in MUX system with XTPB cards installed.

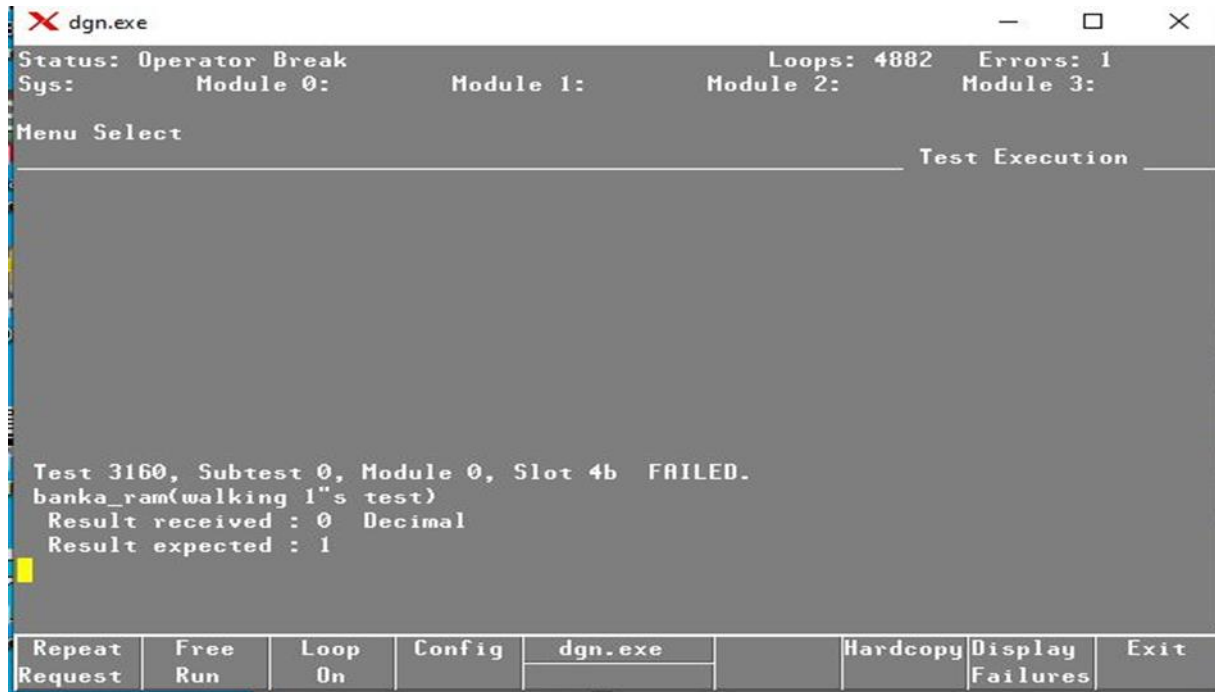
All i3070 Series 6 systems are currently shipped with control XTPB cards. Intermittent T3610 errors are reported during Diagnostics (DGN) on certain batches of pin cards in MUX system only. The following is a screenshot of some of the failures:

A new firmware (v22040514_2) for XTPB card has been developed to address this issue. The new firmware can be downloaded from Keysight.com and the firmware update can be done via DGN.

It is recommended to do the firmware update if the intermittent T3160 errors are encountered, please note:
