E9903G-01

Modification Recommended Service Note

Keysight i3070 Series 6 In-Circuit Test System

Intermittent T3610 errors during Diagnostics (DGN) on certain batches of pin cards in MUX system with XTPB cards installed.

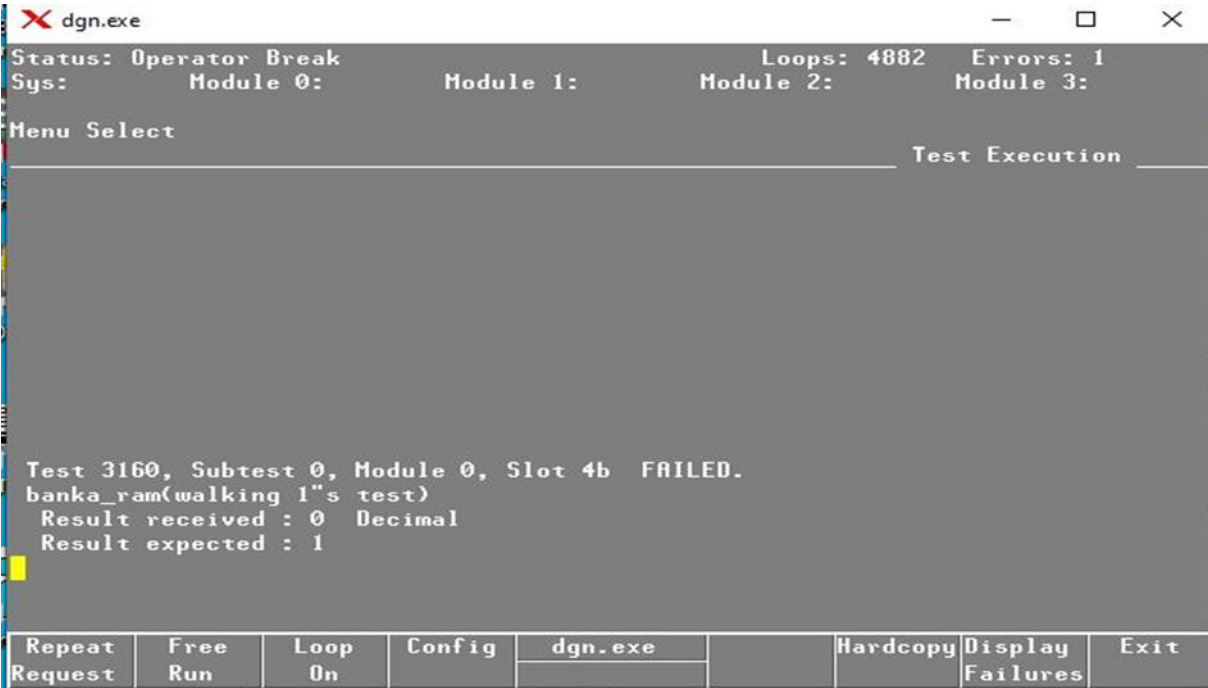
All i3070 Series 6 systems are currently shipped with control XTPB cards. Intermittent T3610 errors are reported during Diagnostics (DGN) on certain batches of pin cards in MUX system only. The following is a screenshot of some of the failures:

A new firmware (v22040514_2) for XTPB card has been developed to address this issue. The new firmware can be downloaded from Keysight.com and the firmware update can be done via DGN.

It is recommended to do the firmware update if the intermittent T3160 errors are encountered, please note:
