SN J1981A -01

S E R V I C E N O T E

J1981A VQT

Updated replacement of FXO Analog card for improved PESQ scores

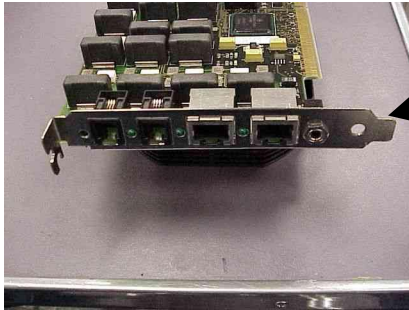
Move metal tab to
new assembly.

Replace the analog FXO E&M card with the latest version. This, along with downloading the VQT application Software Version 4.1.1 or later. When the “defective” analog card is removed the metal grounding tab **MUST** be swapped to the new assembly.
