J7263A-01-S

S E R V I C E N O T E

N2X/OmniBER XM Chassis

Potential power supply failure due to component lead length.

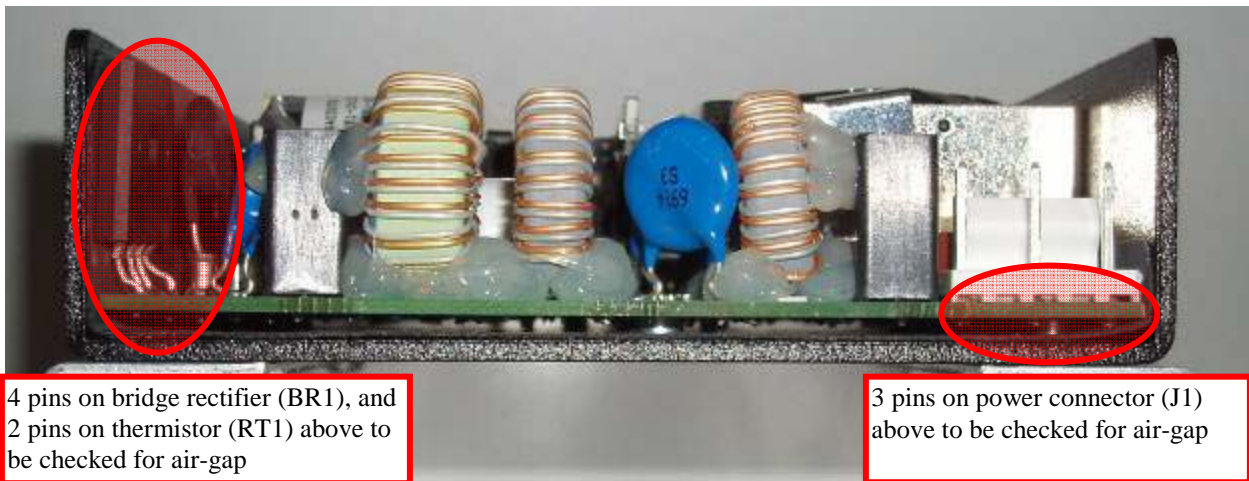
Analysis showed that some through-hole components did not have their leads trimmed to the proper length (they were too long), and as a result of vibration testing done after OEM HiPot tests, or shock/vibration in transit, the extended leads were piercing the insulation barrier between the mains powered components, and the PSU metalwork.

Check the power supply through-hole components as shown below to ensure that there is an air gap between the component leads highlighted and the insulation situated between the metalwork and PCB.

If there is an air-gap, the power supply can be re-fitted to the chassis and returned to the customer after being tested in accordance with the procedures outlined in the above mentioned service manual.

If there is *not* an air gap, then the power supply should be replaced by a new one – part number E7900-64800 – and the defective one should be returned to SPO for credit return to the division manufacturing organisation.
