M3201A-01

# Modification Recommended Service Note

## M3201A PXIe Arbitrary Waveform Generator

Serial Numbers: MY57080100 - MY57479999  
ES56600101 - ES56600145

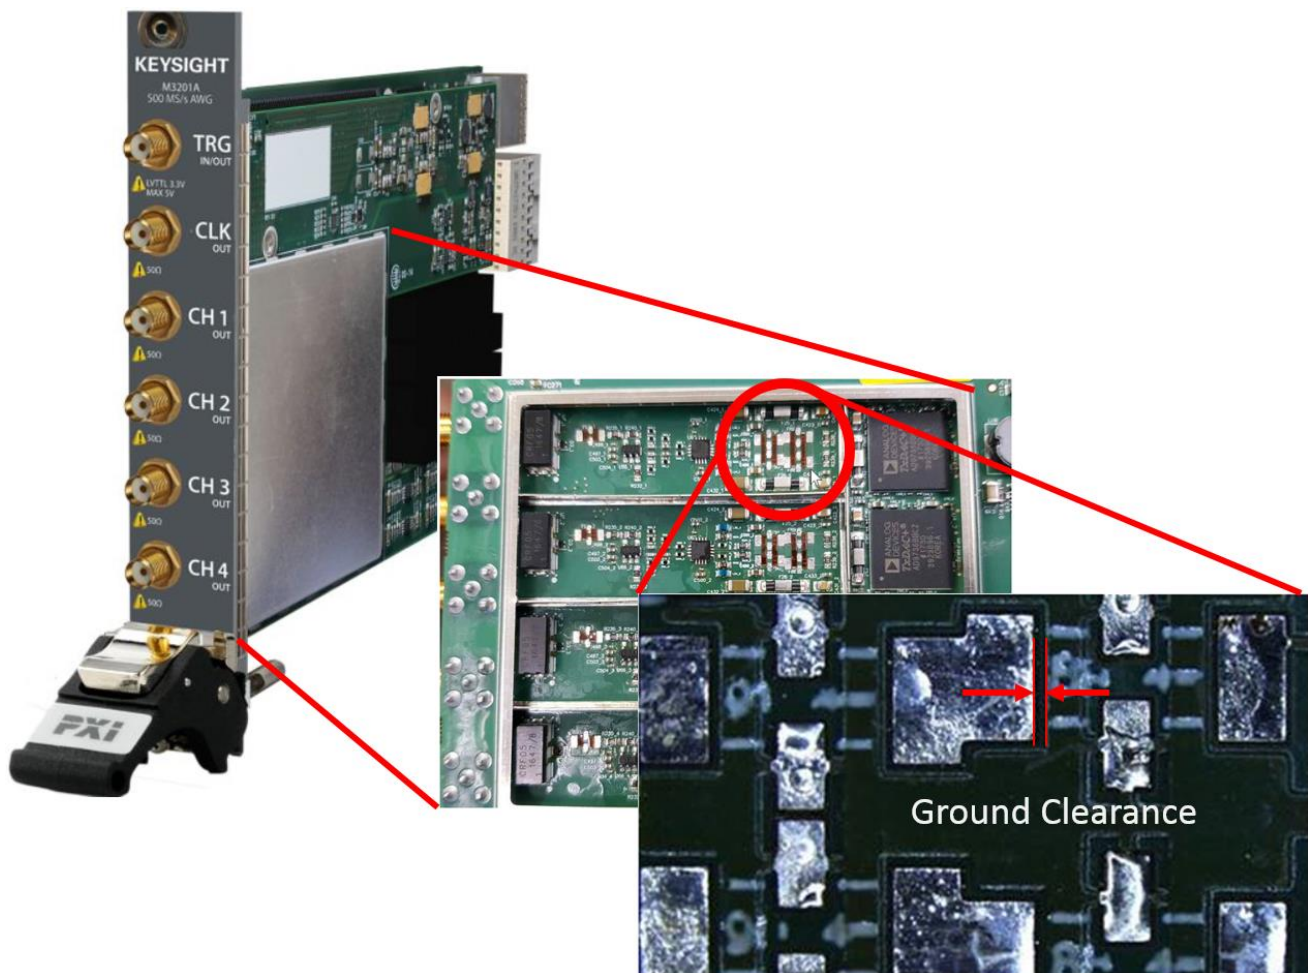
1. A possible short circuit between the filter output pad and the PCB ground plane due to insufficient ground clearance in the PCB design.
2. The performance of the filter changed sometime in 2017 which was not picked up by Keysight. This resulted in unstable DC offset performance after being in operation for some time.

The ground plane clearance problem can be seen below:

These problems have been fixed in all modules, M3201A & M3202A, M3300A & M3302A from MY57510001 onwards.

PXIe AWG M3201A & M3202A and PXIe AWG and Digitizer Combo M3300A & M3302A exhibiting excessive DC offset can be returned to keysight for repair and full calibration.
