M9019A-03

Information Only Service Note

M9019A PXIe Chassis: 18-slot, 3U, 24 GB/s, Gen 3

Code 10 errors under Device Manager for PCI Express to PCI/PCI-X Bridge when use with M9025A.

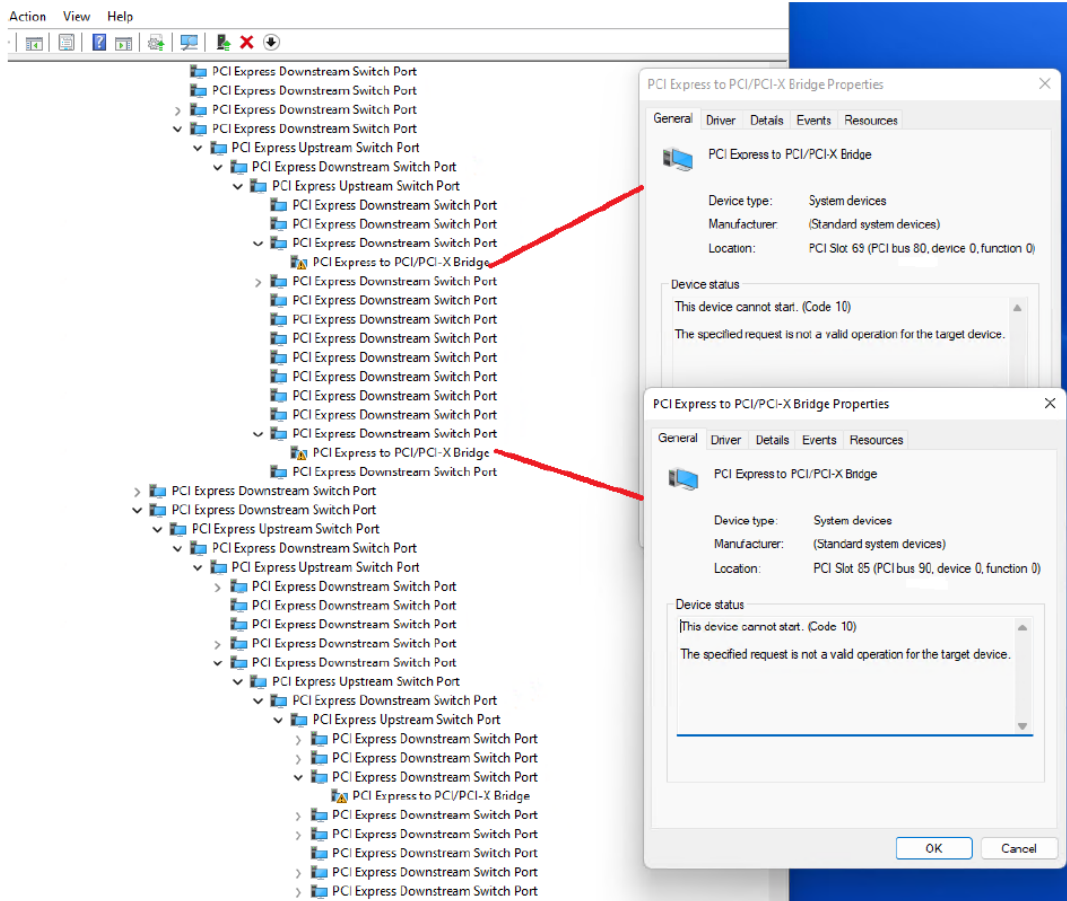
It has been found when the affected chassis are used with M9025A PXIe Thunderbolt System Module that the Device Manager would encounter code 10 errors under the PCI Express to PCI/PCI-X Bridge like picture below.

Follow the steps below to resolve the code 10 errors at the PCI Express to PCI/PCI-X Bridges.

1. Install drivers version 1.7.913.1 or later at the chassis product website www.keysight.com/find/M9019A, navigate to Technical Support > Drivers, Firmware and Software > PXIe Chassis Family Drivers.
2. After updating the drivers, run the update FW tool at the chassis product website www.keysight.com/find/M9019A, navigate to Technical Support > Drivers, Firmware and Software > Chassis Firmware.
 - a. When the *.bin file is run, it will detect the PXI-X switch Firmware needing to be updated like picture below. Press Update to update.
