## M9036A-01B

# S E R V I C E N O T E

## M9036A PXIe Embedded Controller

# Exchange Refurbish Embedded Controller Assembly Repair Strategy for M9036A

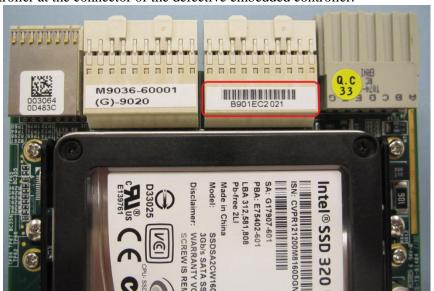
- 5. Locate the Manufacturing Number (Mfg#) (ie. B901EC2021) of the defective embedded controller at the connector of the defective embedded controller.

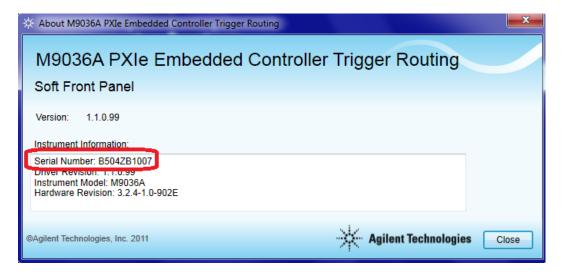
- Follow the instructions in the <u>Keysight M9036A PXIe Embedded Controller Serial</u>
   <u>Number Reprogramming Instructions</u> to reprogram the serial number in the BIOS of the repaired customer embedded controller.
- 2. The repaired customer embedded controller should have the replaced serial number in memory after power cycle. Power up the repaired customer embedded controller with the M9018A and verify the serial number through the Help → About of the embedded controller Soft Front Panel (SFP). Refer to the User's Guide manual on how to get to the SFP. The serial number should match the Keysight serial number located on the front panel assembly of the repaired customer embedded controller.

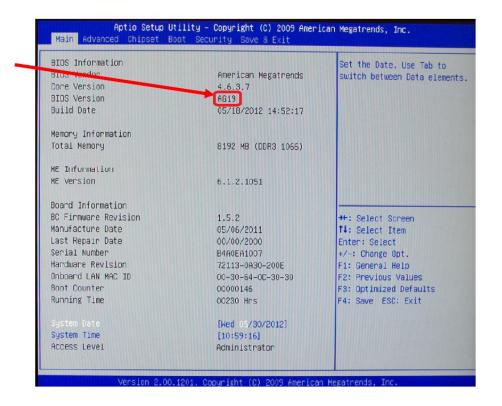
- 2. Power on the M9036A controller.
- 3. Repeatedly press the <Delete> key to open the BIOS menu when the controller beeps. The BIOS setup program will load after a short delay.
- 4. Look at the BIOS version to check if it's the latest. If it is the latest BIOS version, power down the M9036A and skip to step 5. If it is not the latest BIOS version, follow the instructions in the BIOS Upgrade webpage (M9036A BIOS) to upgrade the BIOS then power down the M9036A.
