M9381A-01

S E R V I C E N O T E

M9381A PXIe Vector Signal Generator

Situation:***Absolute Amplitude Accuracy in CW mode.***

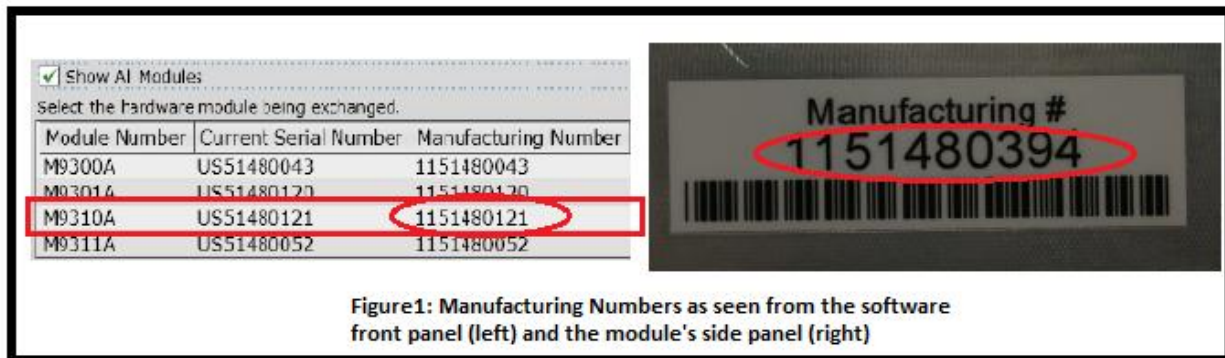
Figure1: Manufacturing Numbers as seen from the software front panel (left) and the module's side panel (right)

Example 1, How to locate the Serial and Manufacturing Numbers: Figure 1 shows examples of the Manufacturing Numbers which can be seen from either the software front panel or the module's right side panel. Figure 2 shows examples of the Serial Numbers which can be seen from either the software front panel or the module's left side panel. This example shows that both the Serial and Manufacturing Numbers are LESS than the specified number and therefore the module must be serviced using the core replacement process.

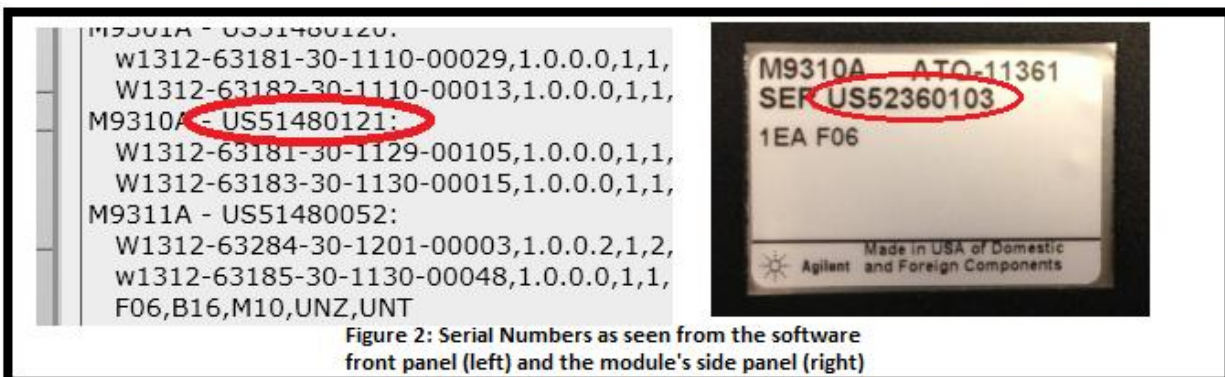
Figure 2: Serial Numbers as seen from the software front panel (left) and the module's side panel (right)
