M9502A-02

S E R V I C E N O T E

M9502A AXIe 2 slot Chassis

Chassis does not appear in the Agilent Connection Expert PXIO tree

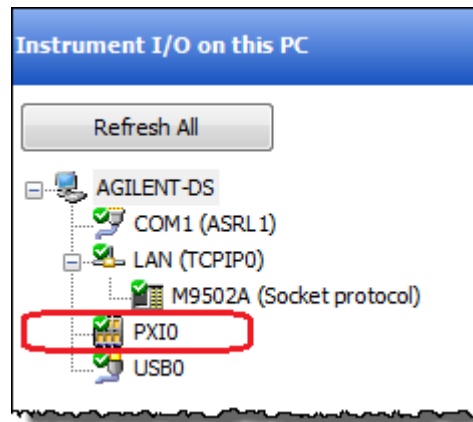
M9502A AXIe chassis that is connected through PCIe should automatically appear under PXIO tree in Agilent Connection Expert. It has been found that when using M9502A affected serial number, firmware, driver, and IOLS described above, the M9502A does not appear in the Agilent Connection Expert PXIO tree. See picture example below:

Reconfiguration of the chassis PCIe interface is needed to fix this issue. This can be accomplished by moving a particular DIP switch on the Embedded System Module (ESM), cycling power on the chassis, and then restoring the original DIP switch position. To reconfigure the chassis PCIe interface, perform the following steps:

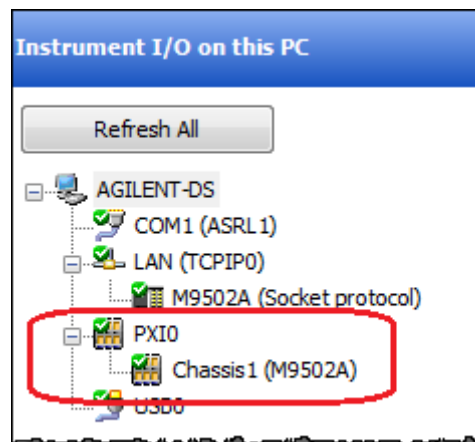
The chassis should automatically appear like this:
