**MSO9104A-02**

# **S E R V I C E N O T E**

## **MSO9104A – 1 GHz Mixed Signal Oscilloscope**

**Intermittent power failure on some 9000 series units.**

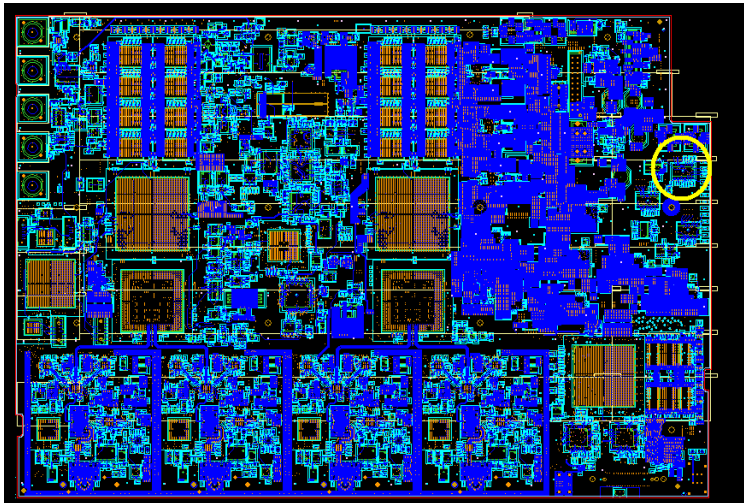
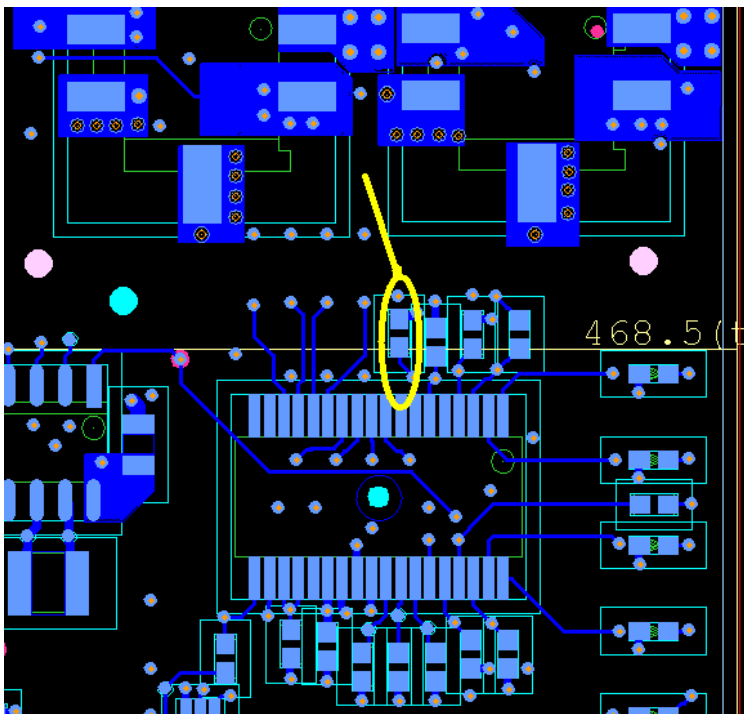
1. Use the disassembly instructions in the service manual to remove the acquisition board.
2. Refer to the below drawings to identify R2830. The area of interest is marked with a yellow circle

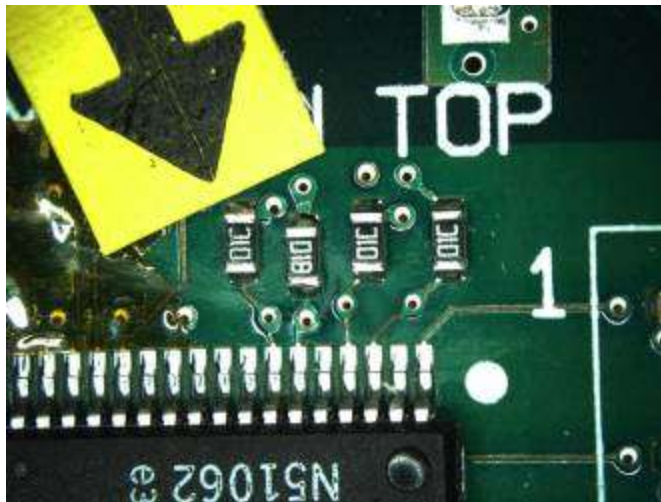
Before modification

A few of the 9000 series scopes randomly turn off. The fix is modifying the power distribution circuit on the acquisition board and dressing the wires that attach to the power supply. Make sure you use RoHS soldering station because the acquisition board components are RoHS compliant

3. Remove existing 10K resistor R2830.
4. Clean the solder pad and install the 10.5K SMD resistor on the pad.
5. Solder the 220nF SMD capacitor on top of the 10.5K resistor as shown in the below picture. Make sure the solder overflows down to the resistor pad entirely. A poorly soldered capacitor won't work as a capacitor.
6. Check the quality of your work by using a multimeter probe tip. Gently touch the lower pad of the capacitor several times. The probe tip introduces enough noise to turn the scope off if the capacitor is not soldered correctly. The capacitor forms a low pass filter to reduce noise. If the capacitor is soldered correctly, noise will not cause the scope to turn off.
