# MSO9104A-03

# S E R V I C E N O T E

## MSO9104A - 1GHz Mixed Signal Oscilloscope

### Repair for Windows "Power surge on hub" message

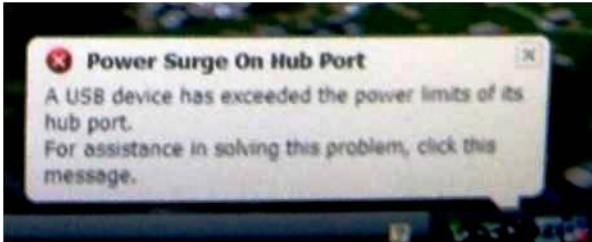
A few scopes display the below message. This upgrade kit installs three components which will resolve the problem and the message should disappear. If the message still appears, either the upgrade was done incorrectly or the motherboard is actually defective.

1. Refer to the service manual to remove the motherboard from the scope.
2. Install the three components from the upgrade kit on the motherboard. Refer to the below drawing and the drawing on the next page for component locations. The 0960-2789 motherboard is RoHS compliant and the below three components are also RoHS compliant. You should use a RoHS soldering station and RoHS solder techniques when possible.
