## MSO9104A-04

**S E R V I C E N O T E**Supersedes:  
None**MSO9104A Oscilloscope: 1 GHz, 4 analog channels**

Serial Numbers: MY0000001-MY52250100, SG00000001-SG52250100

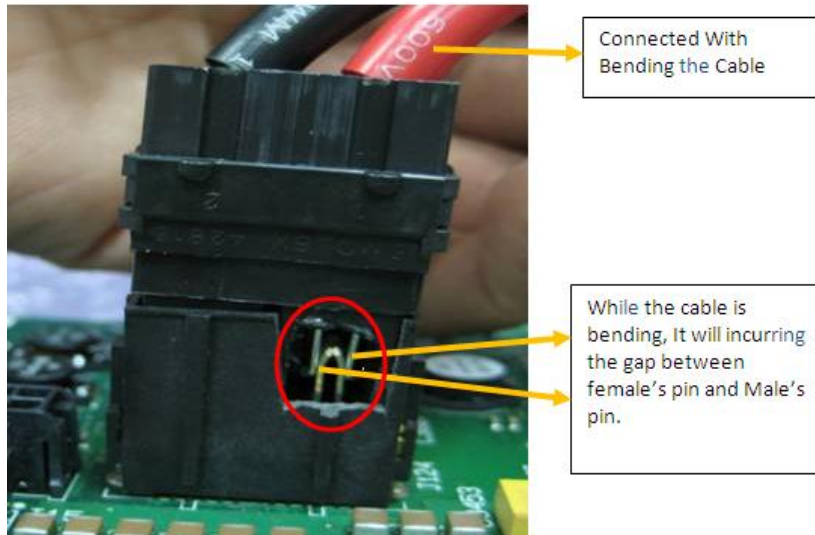
Figure #1.

Many customers are experiencing Random Shutdowns. This make them want to have Service Note - 02A completed. The problem is with service note -02A, this isn't the only possible cause for the symptom consequently not resolving their problems. This issue has been determined to be a connection problem with the J124 connector on the acquisition assembly and the 12 volt power cable. See figure #1.
