# MSO9404A-01

## S E R V I C E N O T E

### MSO9404A 4 GHz Mixed Signal Oscilloscope

Serial Numbers: MY49190101, MY49190102, MY49190103, MY49190104, and MY49190105

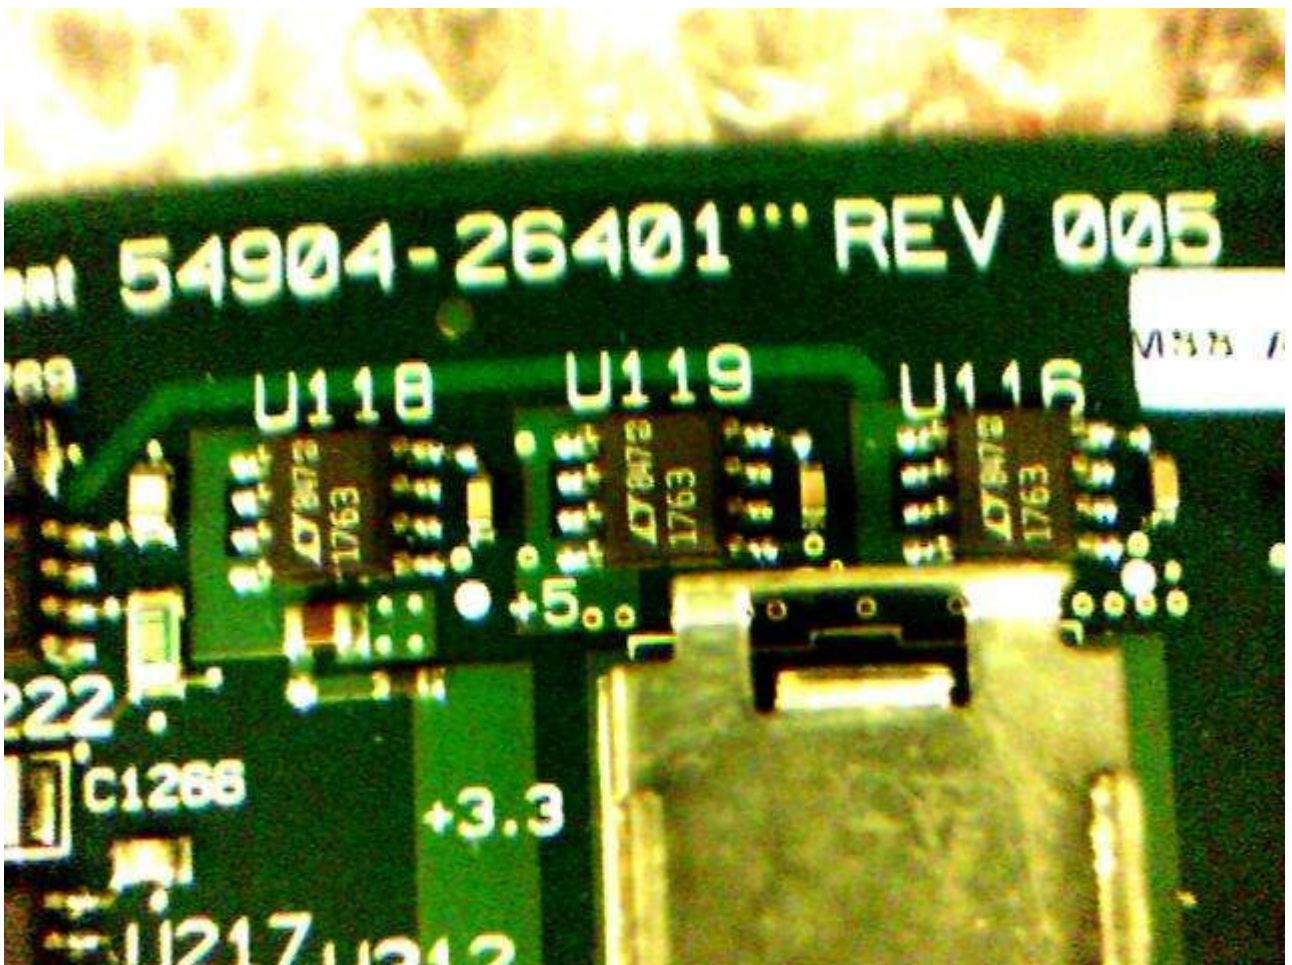
This is a onetime replacement because you are replacing the acquisition board 54901-66501 rev 005 with a later board rev of at least 006. The below picture shows a typical board number with the board rev listed. The board number 5490X-26401 is the raw PC board number. Once the board is loaded with parts and tested, the board number changes to 5490X-66501. The important part of the below picture is that the board rev of 005 is shown. This board must be removed from the scope and returned to SPO. SPO will return the defective board to AMC. You can install a new or refurbished acquisition board in the scope. At the writing of this service note, the new board part number was 54904-66501 and the refurbished part number was 54904-69501. If the board rev is 006 or higher, do not replace the acquisition board with this service note.

Refer to the 9000 series service manual for instructions to remove and replace the acquisition board. Perform the self calibration and self tests to make sure the replacement board is functioning correctly. Run final calibration on the scope and issue a new certificate of calibration. Charge the replacement acquisition board, labor, and calibration time to factory warranty.
