## MSO9404A-04

**S E R V I C E N O T E**Supersedes:  
None**MSO9404A Oscilloscope: 4 GHz, 4 analog channels**

Serial Numbers: MY0000001-MY52250100, SG00000001-SG52250100

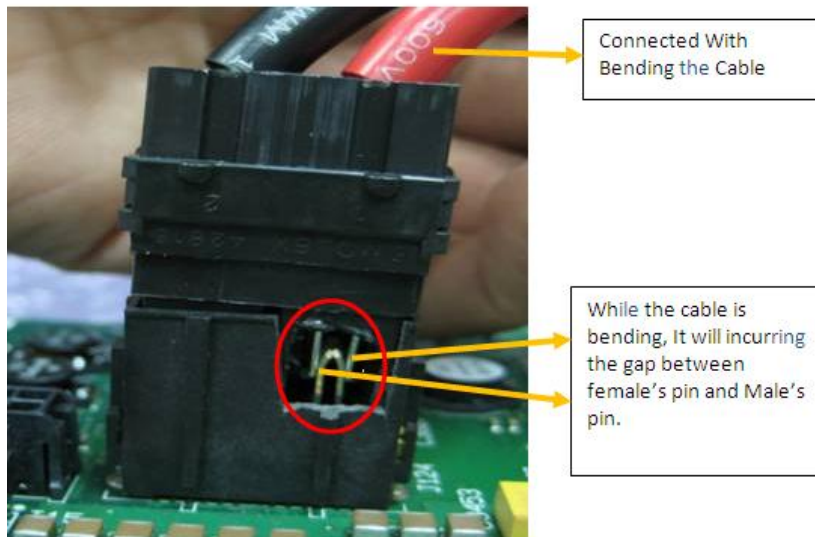
Figure #1.

Many customers are experiencing Random Shutdowns. This make them want to have Service Note - 02A completed. The problem is with service note -02A, this isn't the only possible cause for the symptom consequently not resolving their problems. This issue has been determined to be a connection problem with the J124 connector on the acquisition assembly and the 12 volt power cable. See figure #1.

Replace the 12 Volt Bulk power cable to the longer version 54904-61631 eliminating the connector tilt increasing the surface tension. See Figure #2. Clean and inspect the connection J124 on the acquisition board. If the J124 is pitted then replace the acquisition board. Use contact cleaner or alcohol.
