Modification Recommended Service Note

MSOS054A – MSO Infiniium S Series 500MHz 4 channel

Serial Numbers: MY00000001 - MY58060101; SG58150101 to SG58150103

The Problem – Under certain circumstances a PLL2 error may occur on the S-series products.

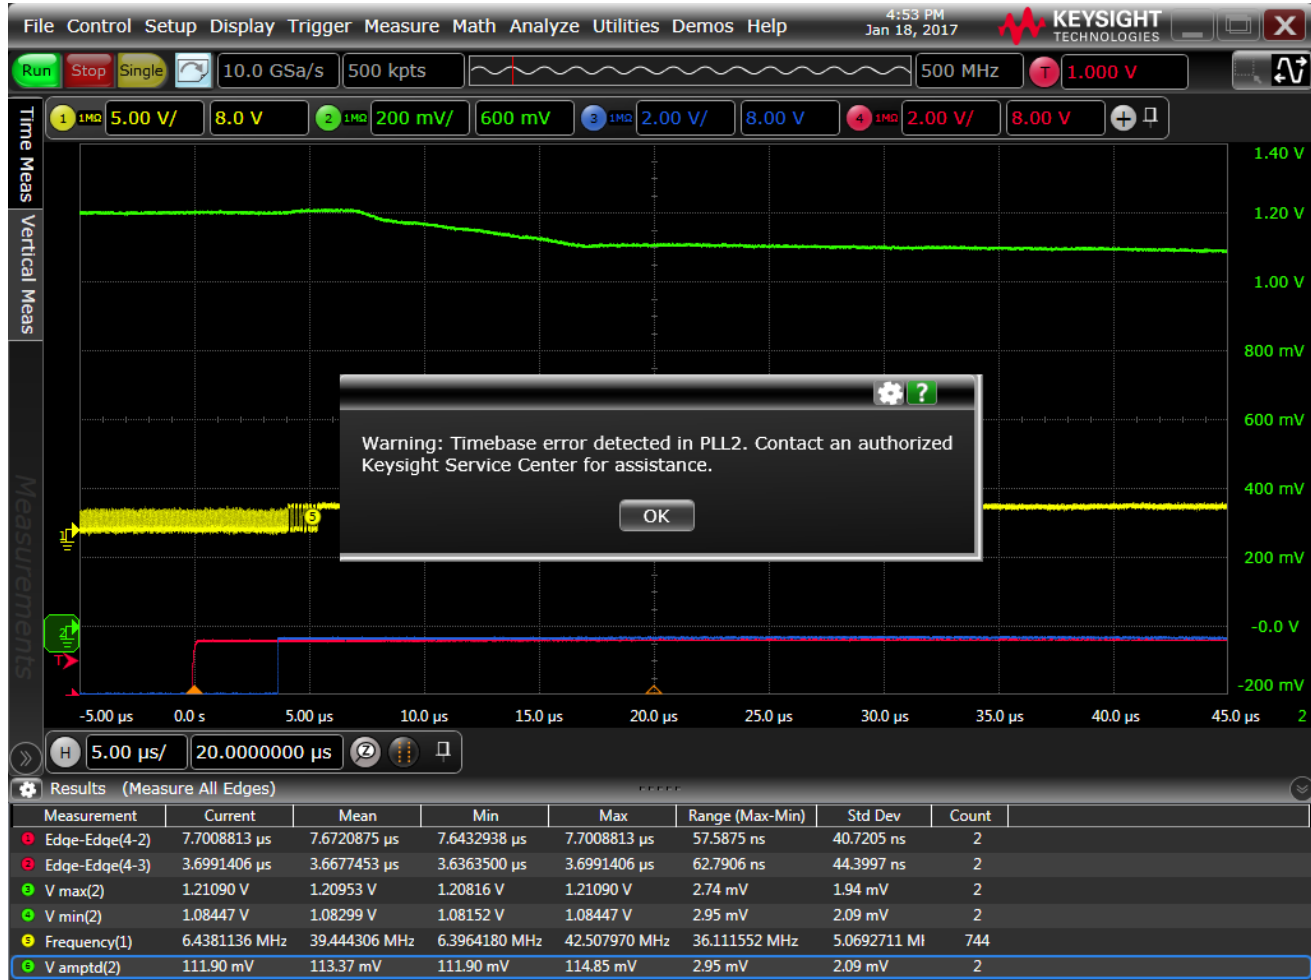
On older acquisition boards a PLL2 error message sometimes occurs. The error message appears on the screen as below:

There are new acquisition boards that fix this issue for the S-series scopes.

Please, use the 54911-69511 board until is gone.
If you have a 54911-69511, then skip steps 1 and 2 and proceed to step 3.
If there are no 54911-69511, then start with step 1 below.

1. If the customer needs to have software revision < 6.10.01001, then replace the acquisition board with the 54911-69532 board.
2. If the customer can have software revision \geq 6.10.01001, then it can be replaced by any of these three boards: 54911-69521, 54911-69531, or 54911-69532.
