Modification Recommended Service Note

MSOS204A – MSO Infiniium S Series 2GHz 4 channel

The Problem – Under certain circumstances a PLL2 error may occur on the S-series products.

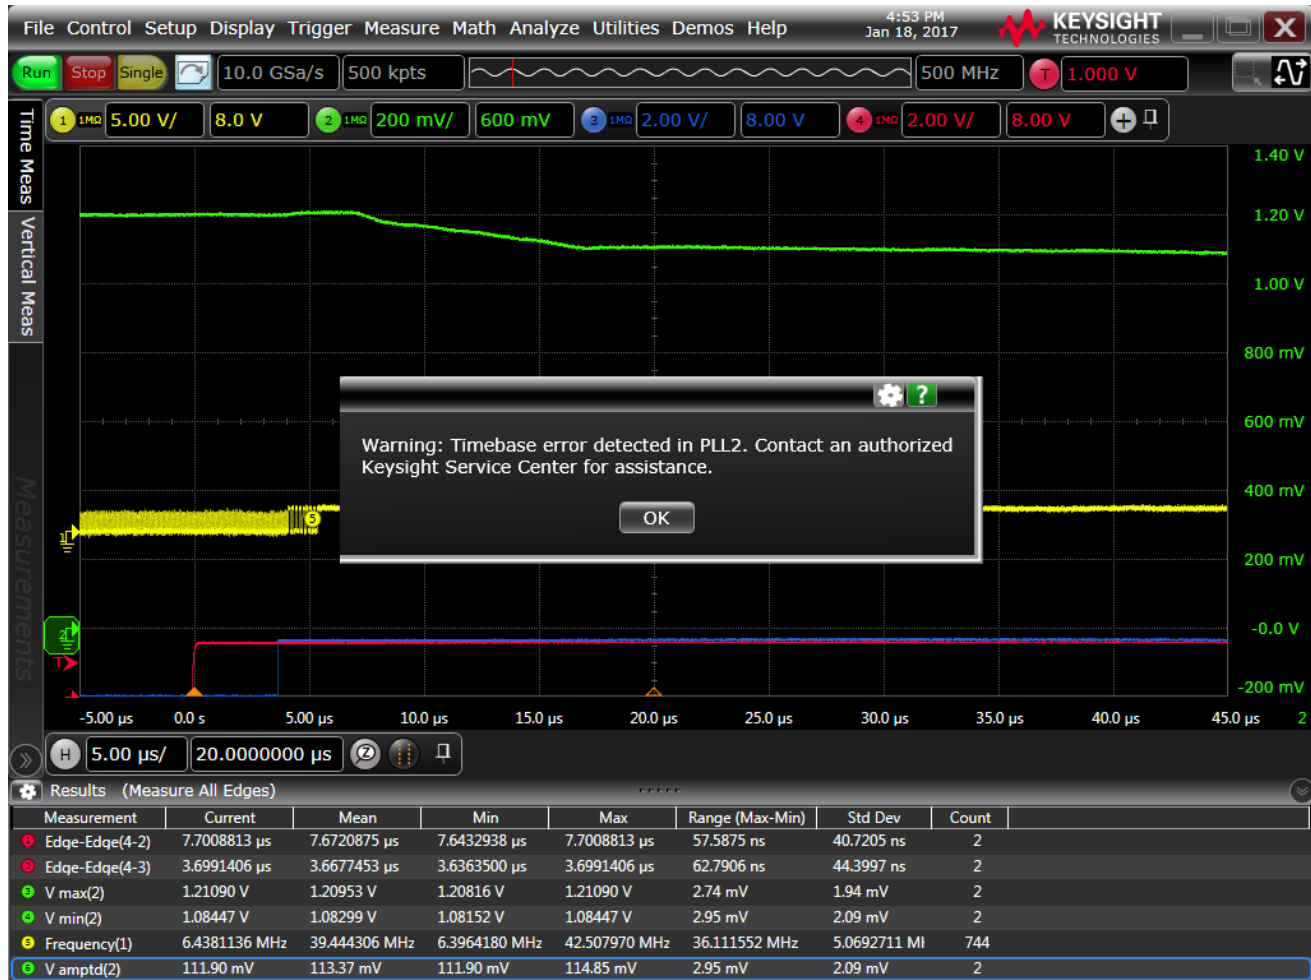
On older acquisition boards a PLL2 error message sometimes occurs. The error message appears on the screen as below:

There are new acquisition boards that fix this issue for the S-series scopes.

1. If the customer needs to have software revision < 6.10.01001, then replace the acquisition board with the 54911-69532 board.
2. If the customer can have software revision \geq 6.10.01001, then it can be replaced by any of these three boards: 54911-69521, 54911-69531, or 54911-69532.
