N1055A-01

# Modification Recommended Service Note

## N1055A - 35/50 GHz 2/4 Port TDR/TDT Remote Sampling Head for the 86100D DCA-X

Serial Numbers: MY00000000-MY57200000

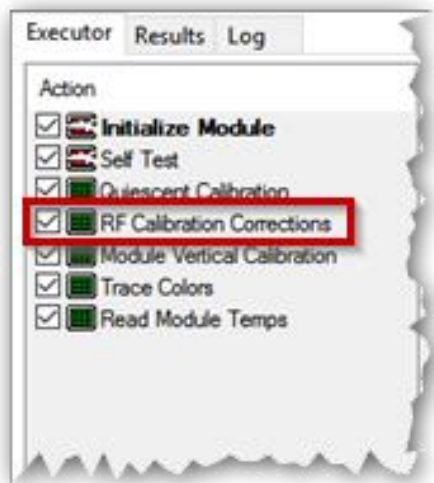
If the test code incorrectly identifies the version of sampler board installed, the RF Calibration Corrections test is expected to fail:

If there is a doubt as to what version of sampler boards are installed in a unit, remove the covers of the remote heads and compare the part number labels to the tables above.
