N1090A-02

Modification Recommended Service Note

N1090A DCA-M Optical and Electrical Sampling Oscilloscope

Extinction Ratio (ER) calibration issue.

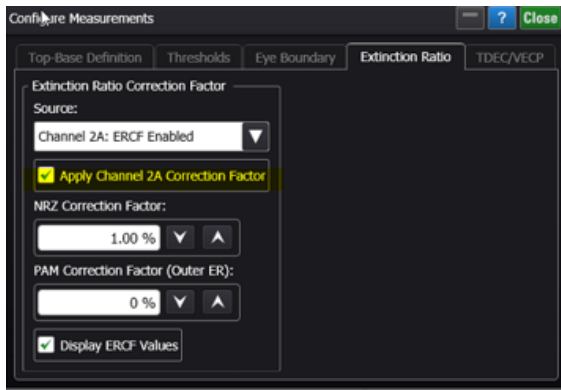
A systematic error was discovered with ER calibration which resulted in the ER correction factor (ERCF) to report higher than expected values, impacting ER measurements of the listed serial numbers built or repaired between June 2023 and September 2023.

This only impacts units that have ERCF enabled, see screenshot below. The default behavior is for the ERCF to be off.

If ERCF is used, it is recommended to send the unit back to Keysight to have a new ER calibration done.

These units have a recommended annual calibration cycle. If the units are not sent in immediately, the ER calibration will be updated the next time that they are sent in for their annual calibration.

If the unit can't be immediately sent in, due to usage, then a possible work-around is to use a "transfer standard" as described in Application Note 5989-2602, link:
